# Measuring Up Accessibility Audit: Selected Parks within the City of Campbell River

Report Prepared for: Measuring Up Committee

Submitted on: Tuesday, September 9<sup>th</sup>, 2008

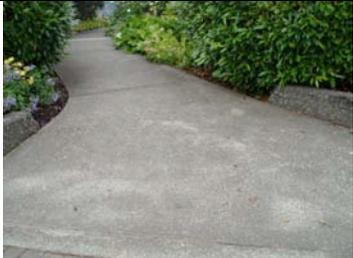
Accessibility Barrier	Potential Solutions	Photo
- Park entrance off the sidewalk on Shopper’s Row has slope greater than 12%	- Rough grade the slope to not greater than 5%

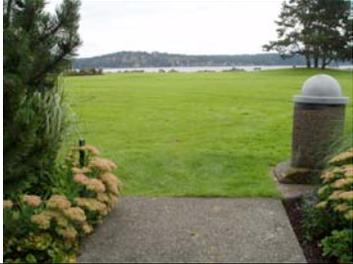
<ul style="list-style-type: none"> <li>- Access off sidewalk on Shopper's Row dead ends at grass</li> <li>- No access to garbage pail</li> </ul>	<ul style="list-style-type: none"> <li>- Continue path into the grassed area, perhaps to the pavilion</li> <li>- Place garbage pail on a cement pad that is attached to the main path</li> </ul>

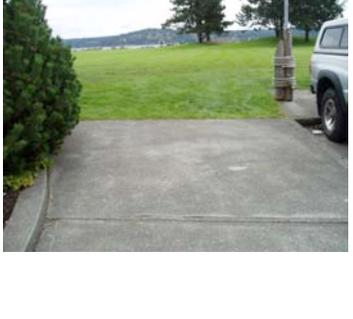
<ul style="list-style-type: none"> <li>- Access path by car park on west side of park has steep slope &amp; steep side hill</li> <li>- Sidewalk dead ends at grass/ goes no where</li> </ul>	<ul style="list-style-type: none"> <li>- Rough grade sidewalk to be level and maximum 5% slope and not greater than 2% cross slope</li> <li>- Continue path from car park around the garden to join the sidewalk discussed above &amp;/or to picnic tables</li> </ul>

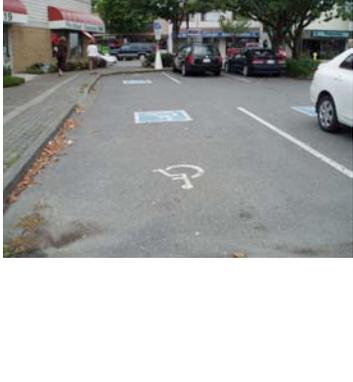
<b>Accessibility Barrier</b>	<b>Potential Solutions</b>	<b>Photo</b>
<ul style="list-style-type: none"> <li>- There are no marked pathways between parking spots ensuring access to vehicles for wheelchair users</li> <li>- No designated parking stalls in the parking lot at the north end of the park</li> </ul>	<ul style="list-style-type: none"> <li>- Reconfigure parking spots allowing for marked pathways between spots (refer to Accessibility Guidelines booklet)</li> <li>- Create a fourth designated parking stall on Shopper's Row as well as designated parking stalls in the lot on the Island Highway</li> </ul>

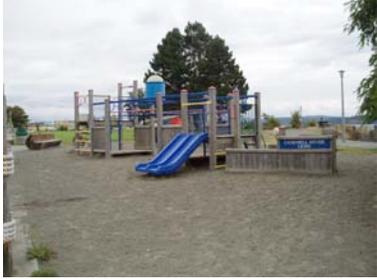
<b>Accessibility Barrier</b>	<b>Potential Solutions</b>	<b>Photo</b>
<ul style="list-style-type: none"> <li>- Soft sand around the playground equipment difficult for wheelchair users</li> <li>- No wheelchair accessible elements in the equipment</li> <li>- No sensory stimulation elements available to children with a variety of disabilities</li> </ul>	<ul style="list-style-type: none"> <li>- Replace sand with fall protection rubber matting</li> <li>- Incorporate wheelchair accessible elements in the climbing apparatus</li> <li>- Incorporate sensory stimulation activities for children with visual and developmental disabilities</li> </ul>

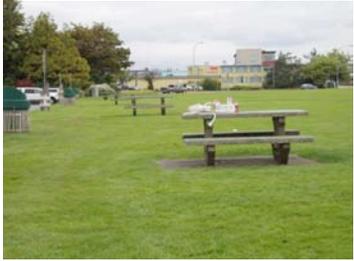
<b>Accessibility Barrier</b>	<b>Potential Solutions</b>	<b>Photo</b>
<ul style="list-style-type: none"> <li>- No wheelchair accessible picnic tables available</li> <li>- Tables are on cement pads surrounded by grass with no accessible path of travel to them</li> <li>- Cement pads are too small for wheelchair to sit on or travel around the table</li> </ul>	<ul style="list-style-type: none"> <li>- Replace one table with wheelchair accessible model and designate it for wheelchair user's priority</li> <li>- Create hard surfaced paths to picnic tables so travel across grass is not required</li> <li>- Enlarge cement pads to have 1500 mm of cement on all sides of the table</li> </ul>

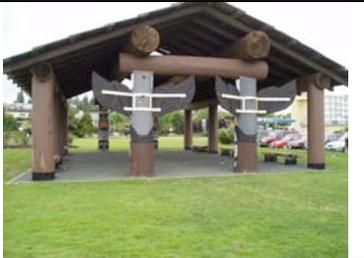
<b>Accessibility Barrier</b>	<b>Potential Solutions</b>	<b>Photo</b>
<p>- The pavilion is located in the middle of a grassed area with no path accessing it off of the sidewalks</p>	<p>- Create a hard surfaced path to the pavilion from the sidewalk</p>

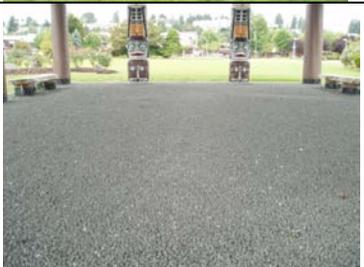
<p>- The floor of the pavilion is loose gravel making mobility very challenging for physical disabilities</p>	<p>- Replace gravel with a chip stone, hard surfaced material to allow for mobility but maintain the aesthetic</p>

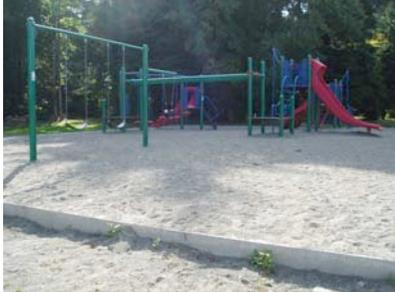
Accessibility Barrier	Potential Solutions	Photo
<ul style="list-style-type: none"> <li>- The playground is elevated on raised platform with a 180 mm lip from the surrounding ground up onto the play area</li> </ul>	<ul style="list-style-type: none"> <li>- Rough grade the surrounding area to have a gentle rise (2-3%) to the play area ensuring no lip to negotiate to enter</li> </ul>

<ul style="list-style-type: none"> <li>- The loose sand within the play area makes it very difficult for individuals with mobility deficits to mobilize</li> </ul>	<ul style="list-style-type: none"> <li>- Replace the sand with crash absorbent rubber matting</li> </ul>	<ul style="list-style-type: none"> <li>- See above photo</li> </ul>
<ul style="list-style-type: none"> <li>- There are no wheelchair accessible elements within the play equipment</li> <li>- There are no sensory stimulation activities appropriate for kids with sensory or cognitive disabilities</li> </ul>	<ul style="list-style-type: none"> <li>- Create activities that require less physical ability and stimulate the senses</li> <li>- Create play areas where kids with disabilities can play equally with able bodied children</li> <li>- Create levels that children in wheelchairs can access</li> </ul>	<ul style="list-style-type: none"> <li>- See above photo</li> </ul>

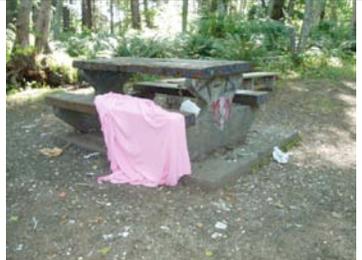
Accessibility Barrier	Potential Solutions	Photo
<ul style="list-style-type: none"> <li>- The picnic table models are not wheelchair accessible as they do not allow a wheelchair user to slide under the table to sit comfortably while doing activities on the table top</li> <li>- The cement pad the tables sit on is too small to allow a</li> </ul>	<ul style="list-style-type: none"> <li>- Replace the tables with wheelchair accessible models</li> <li>- Create cement pads for the tables to sit on that have cement a min of 1500mm around the outside of the table</li> <li>- When rough grading the</li> </ul>

wheelchair to maneuver around the table - There is significant lip (100mm) to get up onto the cement pad from the surrounding ground	trails ensure there is no lip to negotiate to get close to the table from the trails	
- The tables are surrounded by many dangerous materials (broken glass) making the tables dangerous to use	- Have municipal staff clean the areas around the tables regularly to ensure they are clean for everyone's use	- See above photo

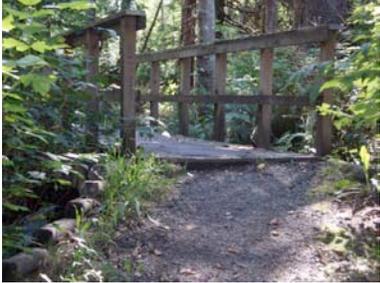
- All of the bridges have lips that must be negotiated getting on and off the bridge deck - These lips can be as high as 100mm and prevent wheelchair users from accessing the bridges independently and present a tripping hazard to walkers	- When rough grading the trails ensure the trail is flush and level with the bridge deck

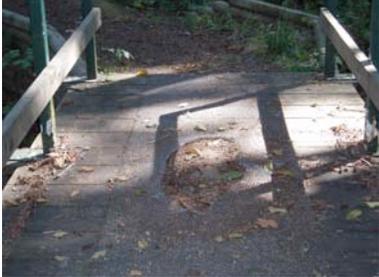
<p>- Many of the wire mesh runners on the bridge decks have holes in them creating tripping hazards</p>	<p>- Replace/ repair the metal mesh runners on the bridge decks</p>

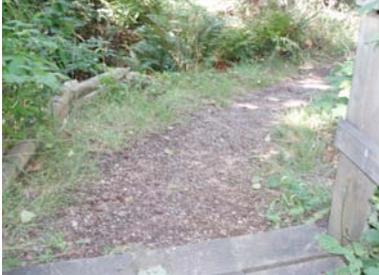
<p>- The natural wood color of the bridge decking is very similar to the trail color creating transitions that are difficult to see and create a tripping hazard</p>	<p>- Paint the last wooden planks on either end of the bridge decks a bright yellow to help with visual discernment</p>

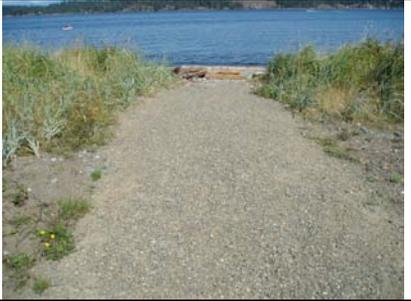
<b>Accessibility Barrier</b>	<b>Potential Solutions</b>	<b>Photo</b>
- The packed dirt trail that accesses the beach area off the main trail has a slope of >12% as it approaches the beach	- Rough grade the slope to less than 5% slope ratio - Create a level spot at the beaches edge for wheelchair users to sit comfortably and enjoy the waterfront environment

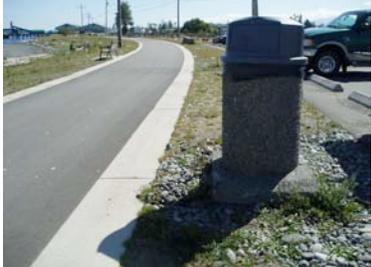
Accessibility Barrier	Potential Solutions	Photo
<p>- Garbage pales are not located on the edge of paths, users must cross grass or dirt to access them</p>	<p>- Create cement pads that the pales sit on link to the main trail</p>

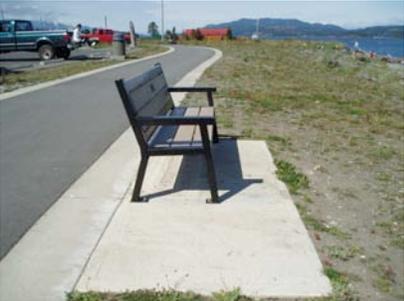
Accessibility Barrier	Potential Solutions	Photo
<p>- The cement pads the benches sit on do not have sufficient space in front of the benches for wheelchair users to maneuver and turn around</p>	<p>- Enlarge the cement pads to include 1500mm of cement all around the benches to allow wheelchairs and other mobility aids easy access</p>

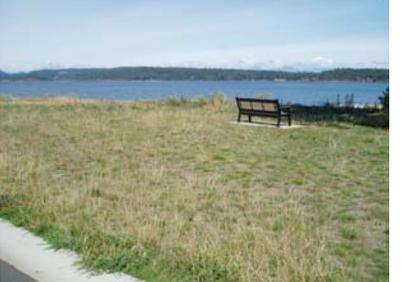
<p>- Some of the benches with the best sea side viewing are located across wide expanses of grass and rough ground</p>	<p>- Create cement paths linking these benches to the main trail</p>

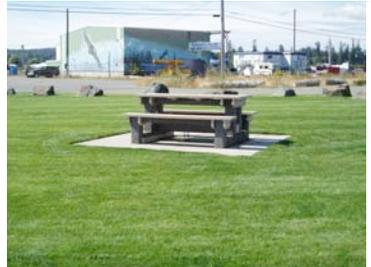
Accessibility Barrier	Potential Solutions	Photo
<p>- The picnic tables do not have wheelchair accessible spots</p>	<p>- Replace the tables with universally accessible designs</p>

<p>- The cement pad the tables sit on are too small to allow mobility aids and their users to circumnavigate the table</p>	<p>- Enlarge the cement pad to allow 1500mm of pad on all sides of the tables to allow disability access</p>	<p>- See above photo</p>

on the hard surface	amovement	
- There are no hard surfaced trails linking the main trail to the picnic tables requiring users to mobilize across soft grass	- Create cement paths that link some of the tables to the parking areas &/or the main trail	- See above photo

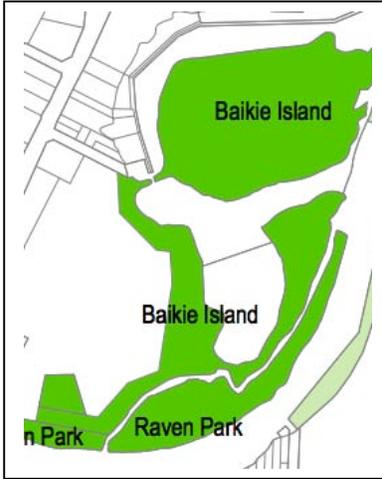
## Baikie Island Trail

Baikie Island Trail is a park that is currently undergoing alterations and redevelopment so perhaps represents the best/ easiest/ inexpensive park, of the ones selected, to apply universal accessibility concepts to in its development.

The Trail is accessed in Campbell River North and is difficult to find, as there are no signs directing users to this area. The main activities available within the park at this point appear to be walking, nature and bird watching and berry picking. There are wooden kiosks that have been erected at the entrance to the park as well as on the second gravel trail within the park, but as of yet they contain no information.

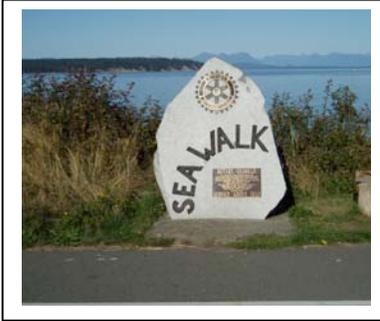
## The Rotary Sea Walk

The Rotary Sea Walk runs along the waterfront for approximately 8 kilometers through Campbell River. The trail is the most heavily used park/ trail of the ones assessed and represents an important component in the healthy, active lifestyle of Campbell River's residents and visitors. The park is used for all modes of non-motorized transportation from running and walking to biking and in-line skating. The trail is used heavily throughout the year.

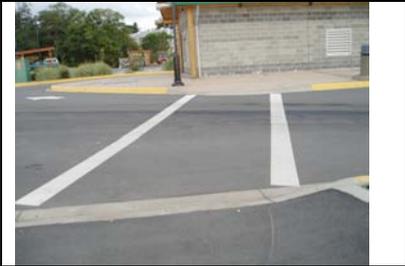
<p>- There are no warnings for visually impaired users at intersections &amp; cross roads (i.e.) Ken Forde Boat ramp</p>	<p>- Install tactile warning strips at intersections to warn of transition zones or obstacles</p>

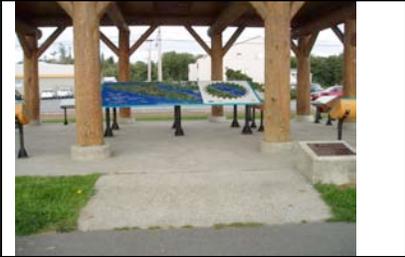
<p>- The access ramp at the Seawalk Center Displays is &gt;8%</p>	<p>- Reduce the ramp's slope to not greater than 5%</p>

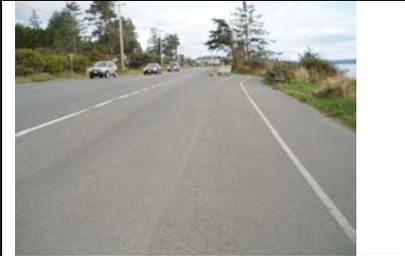
<p>- The bus stops along the trail have continuous smooth cement from the trail out into the highway creating a danger for a cane using visually impaired individual</p>	<p>- Install an edge along the trail for way finding and to keep visually impaired individuals on the trail and not walking out into traffic</p>

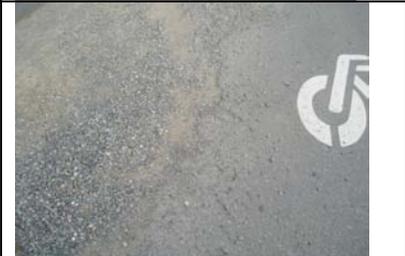
<p>- The trail has many points where gravel has come onto the road side of the surface creating a tripping hazard</p>	<p>- Routinely have the trail swept to keep debris and gravel off the trail surface</p>

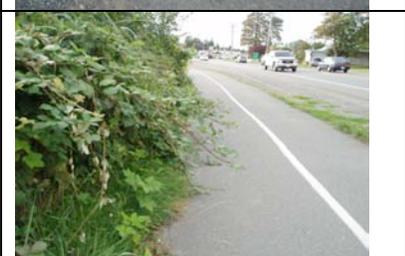
<p>- Black berry bushes encroach on the trail surface in spots creating injury possibilities</p>	<p>- Keep all plant material trimmed and off of the trail area</p>

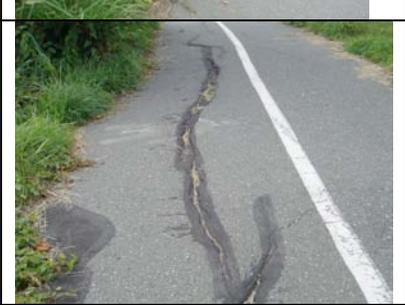
<p>- The trail surface across from Rockland Rd is cracking and potholed creating tripping hazards</p>	<p>- Repair and resurface the trail to ensure a smooth, level surface</p>

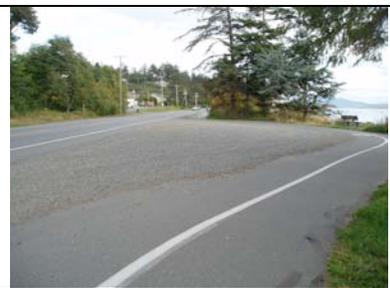
<ul style="list-style-type: none"> <li>- The trail is very curvy making it very difficult for individuals with visual impairments to stay on the trail in the absence of way-finding edges</li> </ul>	<ul style="list-style-type: none"> <li>- Straighten out some of the more severe twists and turns and include way-finding edging along the length of the trail</li> </ul>

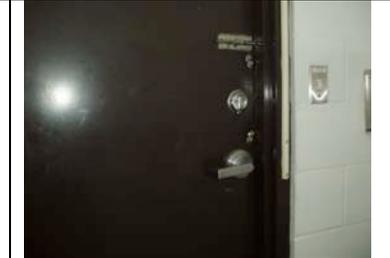
Accessibility Barrier	Potential Solutions	Photo
<ul style="list-style-type: none"> <li>- The lock on the inside of the bathroom door at the Ken Forde boat ramp required finger function to operate</li> </ul>	<ul style="list-style-type: none"> <li>- Replace the locking mechanism with a paddle or lever model</li> </ul>

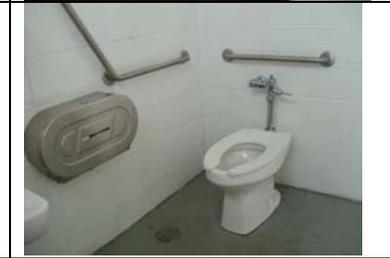
<ul style="list-style-type: none"> <li>- The toilet in the bathroom at Ken Forde boat ramp is very low (410mm) making it difficult for wheelchair users to transfer and individuals with physical challenges to stand up</li> </ul>	<ul style="list-style-type: none"> <li>- Replace the toilet with a taller model</li> </ul>

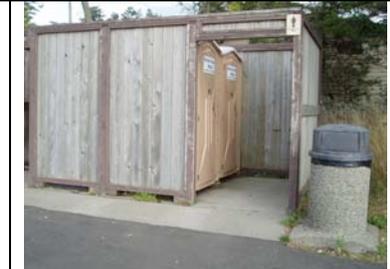
<ul style="list-style-type: none"> <li>- The porta-potties on the trail are not wheelchair accessible</li> </ul>	<ul style="list-style-type: none"> <li>- Replace on of the units on both the men's and ladies' sides to accessible models</li> </ul>

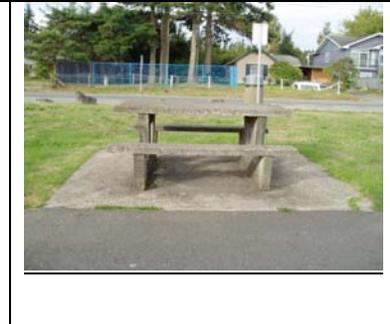
Accessibility Barrier	Potential Solutions	Photo
<ul style="list-style-type: none"> <li>- The picnic tables are not wheelchair accessible designs</li> <li>- The cement pad the picnic tables sit on are not large enough for a wheelchair to circumnavigate the table on the cement</li> <li>- The tables are often on</li> </ul>	<ul style="list-style-type: none"> <li>- Replace picnic tables with wheelchair accessible design</li> <li>- Enlarge cement pads to allow 1500mm of cement all around the footprint of the table for mobility</li> <li>- Create hard surfaced paths that connect the picnic table</li> </ul>

cement pads in the middle of large expanses of grass making it difficult to get to them	pads to the main trail	
---	------------------------	--
