City of Campbell River
Marine Foreshore Habitat Assessment and
Restoration Plan

FINAL REPORT

Northwest Hydraulic Consultants Ltd.
Current Environmental
Murdoch de Greeff Inc.

December, 2011

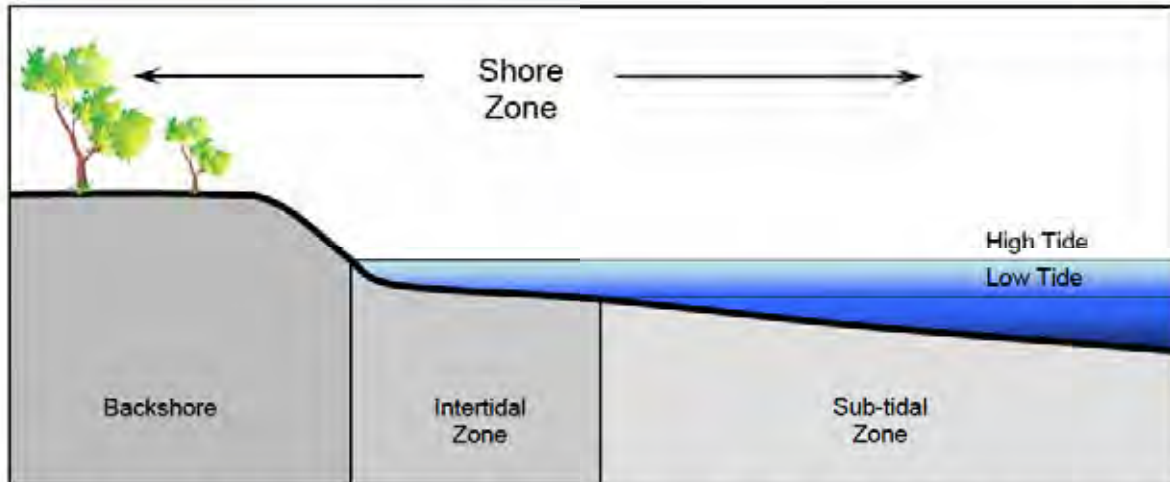
Figure 1. Cross section of the shoreline delineating the various shore zones.

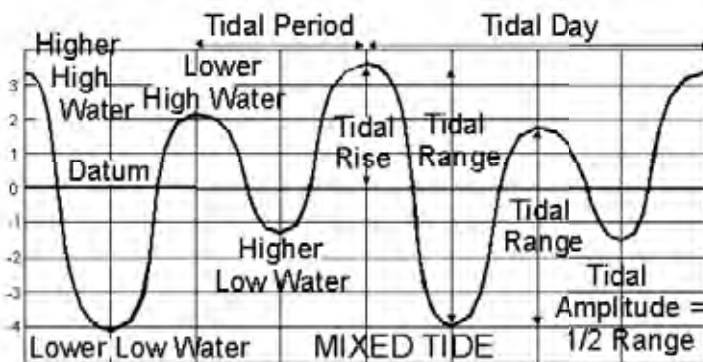
Figure 2. Mixed semi-diurnal tidal pattern (from *Our Restless Tides*, NOAA, 1998).

Tide levels in the Strait of Georgia are mixed, mainly semi-diurnal – meaning that there are two high, and two low tides each day of unequal height (**Figure 2**). Tide levels are typically described in terms of Chart Datum but for the purposes of this report, all elevations have been converted to Geodetic Datum (GSC). **Table 6** summarises the tidal statistics for the Campbell River gauge (Station 8074). Extreme high tides are caused by a number of factors including:

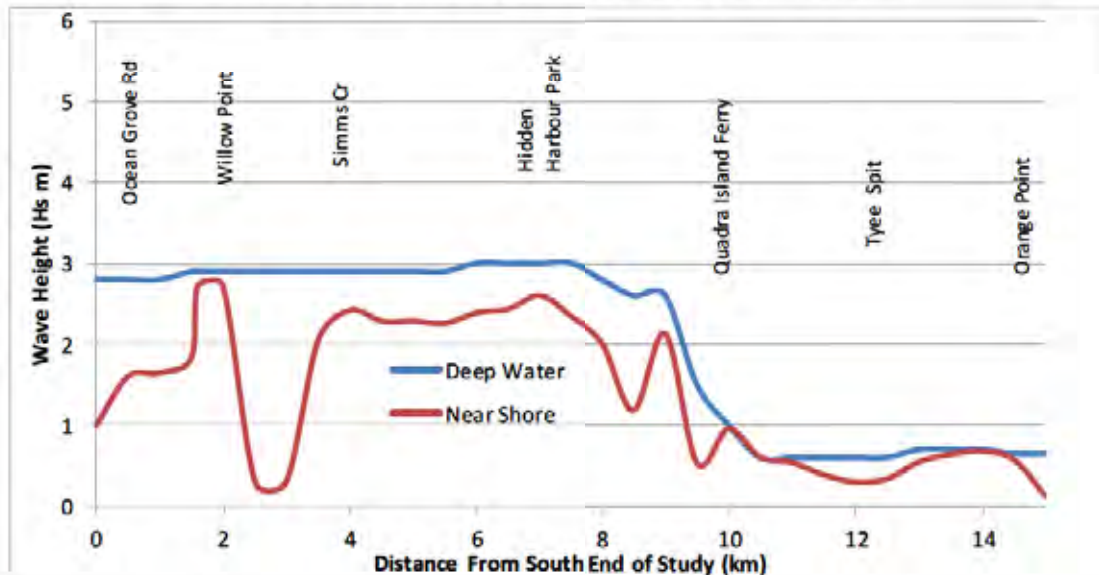
Figure 4. Variation in wave height along the shoreline at Campbell River – December 23, 2010 storm event.

A more accurate method of wave hindcasting involves using a numerical model that represents the time varying wind field over the Strait of Georgia and estimates wave generation as well as the effects of sheltering, wave breaking and wave decay over the storm event. The program SWAN Version 40.81 (2010) was selected for the analysis (DELFT 2010). The model used a nested grid with 1000 m spacing in the southern end of the Strait of Georgia and 200 m spacing north of Sentry Shoal, Oyster River, including the main study area around Campbell River. Figure 4 shows a graph in the variation of deep water versus near shore wave heights for various locations along the Campbell River shoreline during the recent 23 December 2010 storm event.

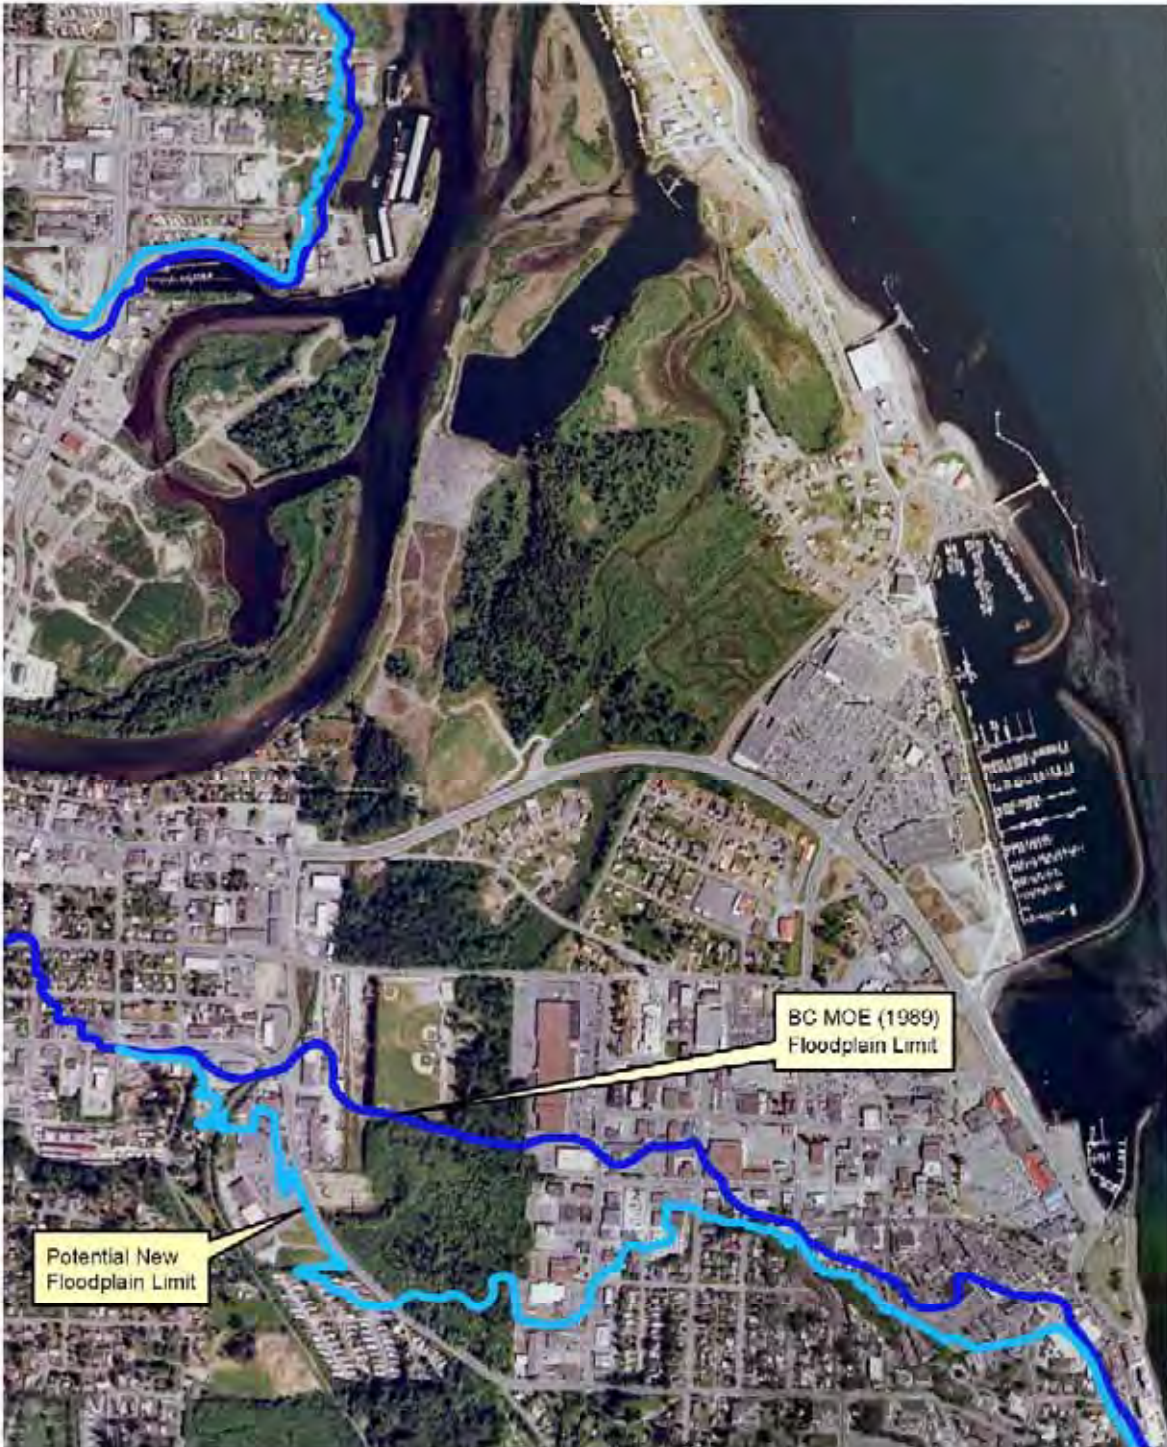
Figure 5. Floodplain extents based on existing mapping (Campbell and Quinsam Rivers, BC MOE, 1989) and on projected future sea level rise scenario.

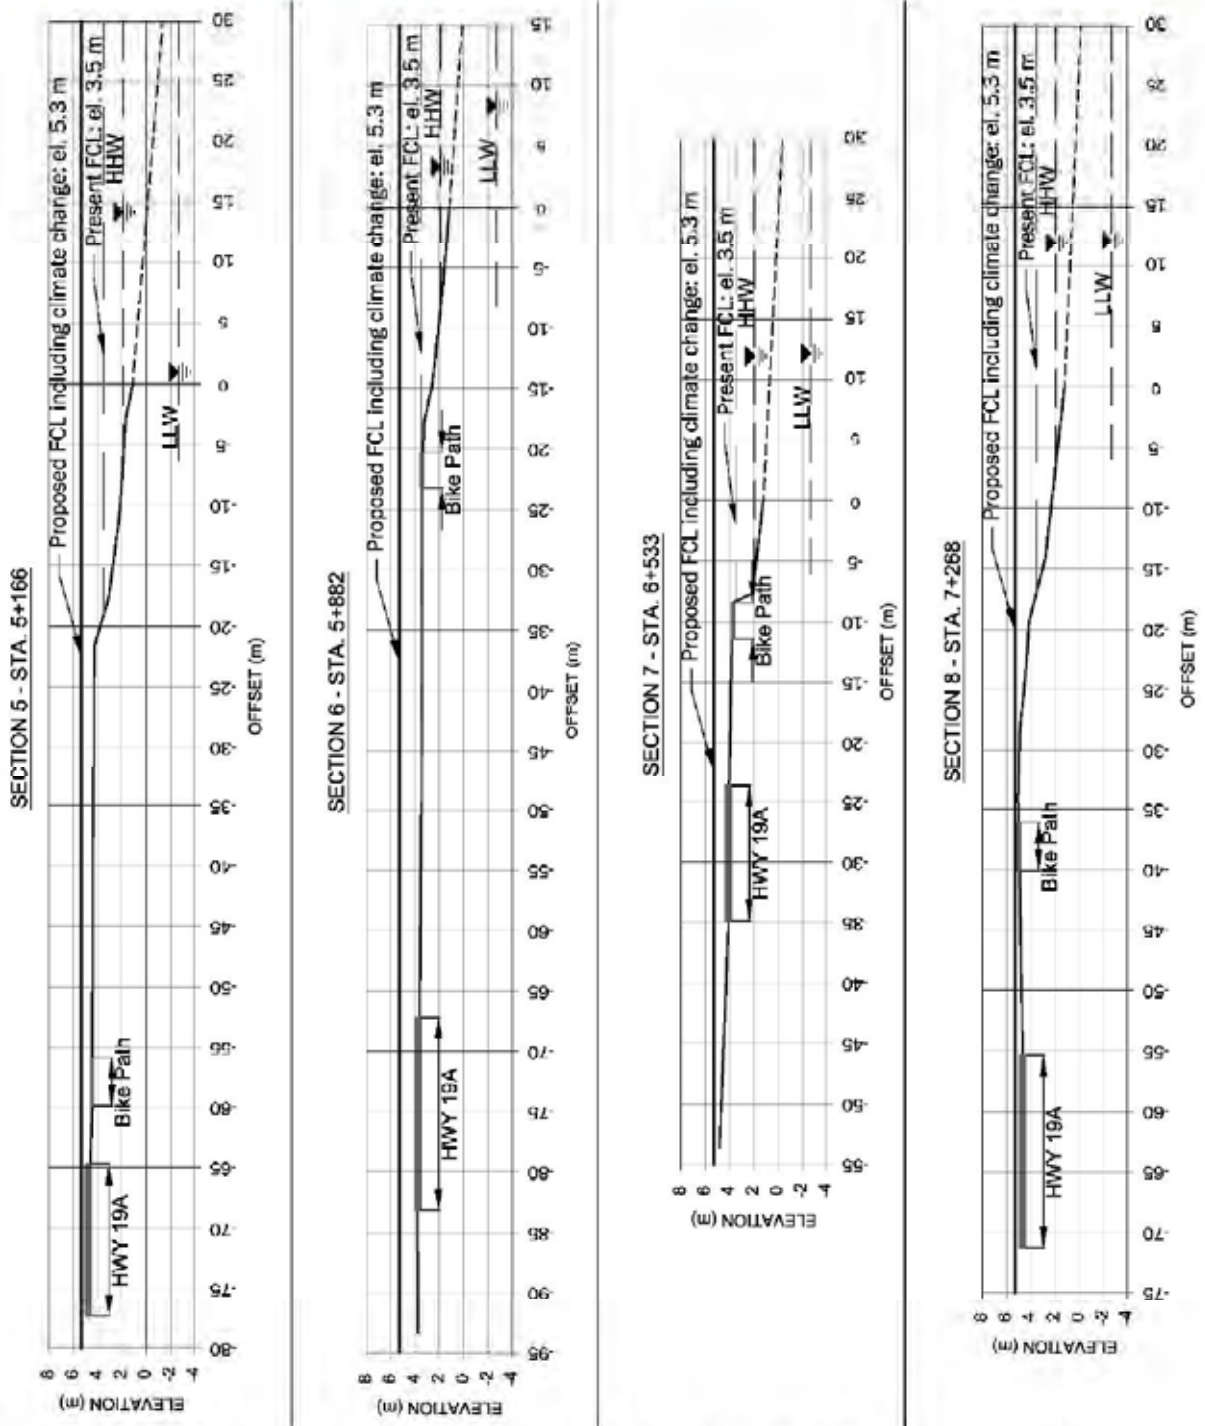
Figure 7. Shoreline profiles-sections 5 to 8 showing BC MOE's present and proposed FCL.

Shoreline cross sections surveyed in January 2011 illustrate the effect of the increased coastal flood level at various locations in the southern portion of the study area. **Figure 6** and **Figure 7** show the sections, along with the present coastal FCL for Discovery Passage and the proposed coastal FCL including climate change (June 2010 Draft). BC MOE's proposed updated FCL is higher than many sections of the existing highway and will designate many presently developed areas as floodplain. For example, see **Figure 8**, photos of a surveyor indicating the elevation of the proposed sea level rise at locations within the study area. It should be noted that the coastal FCL in the southern portion of the study area will be somewhat higher than the 5.3 m value, since this section is more exposed and is subject to greater wave runup. Therefore, the flood levels shown in **Figure 6** and **Figure 7** are intended solely to show the effect of sea level rise on the flood extent and are not intended for regulatory purposes. Nor do these cross sections show the building setbacks that are proposed in these studies (see **Appendix A**). This revised setback definition could affect future land use over a large portion of the study area.

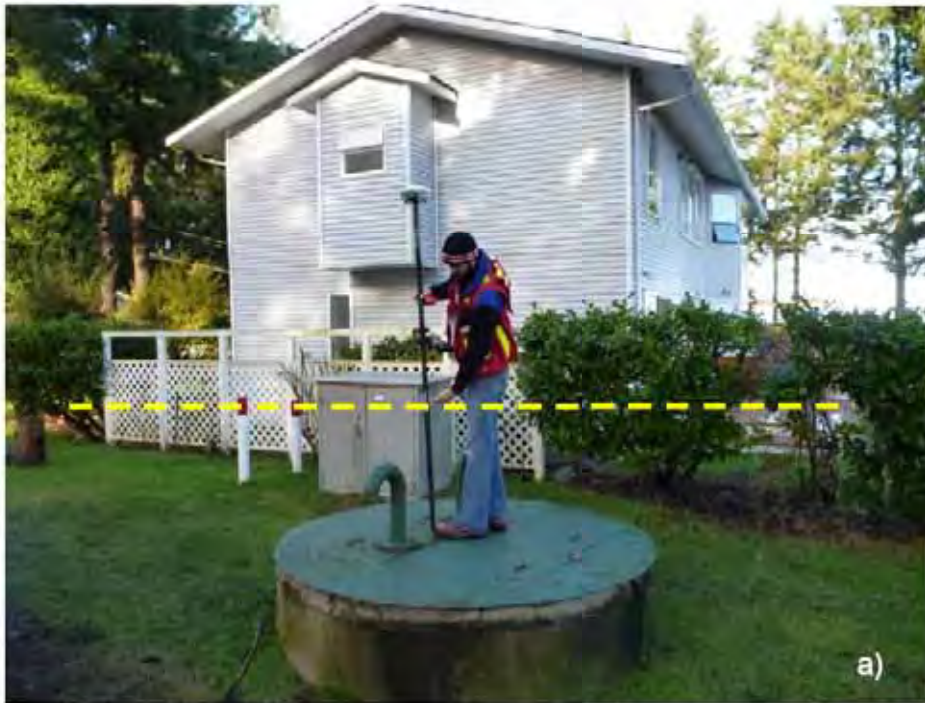
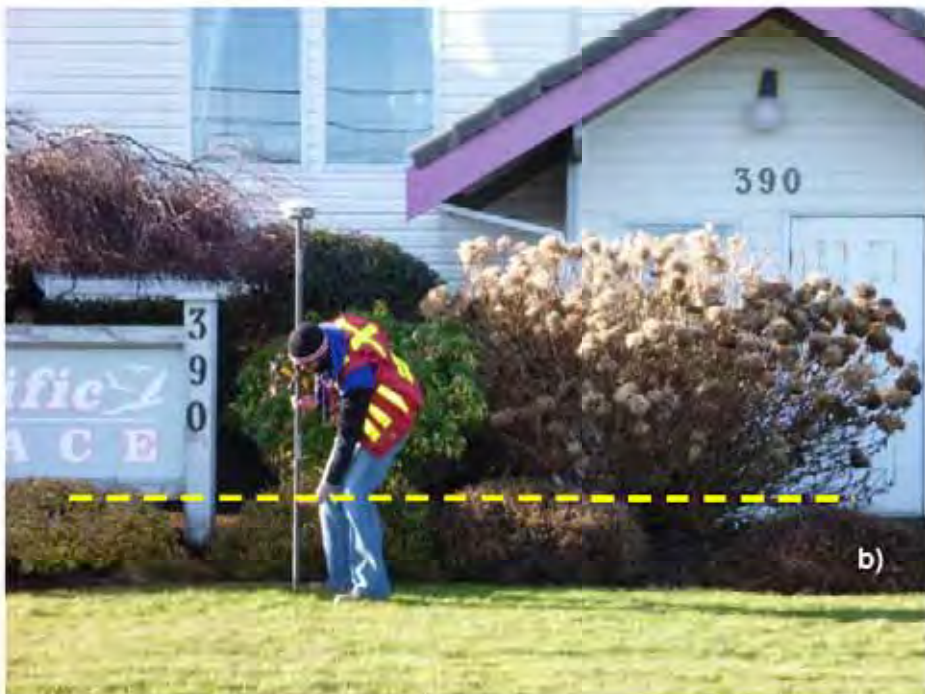
Figure 8. Surveyor indicating the elevation of the draft BC Flood Construction Level (with proposed sea level rise included at a) Ocean Grove, and b) near Rotary Beach Park (photos taken 17 January 2011).

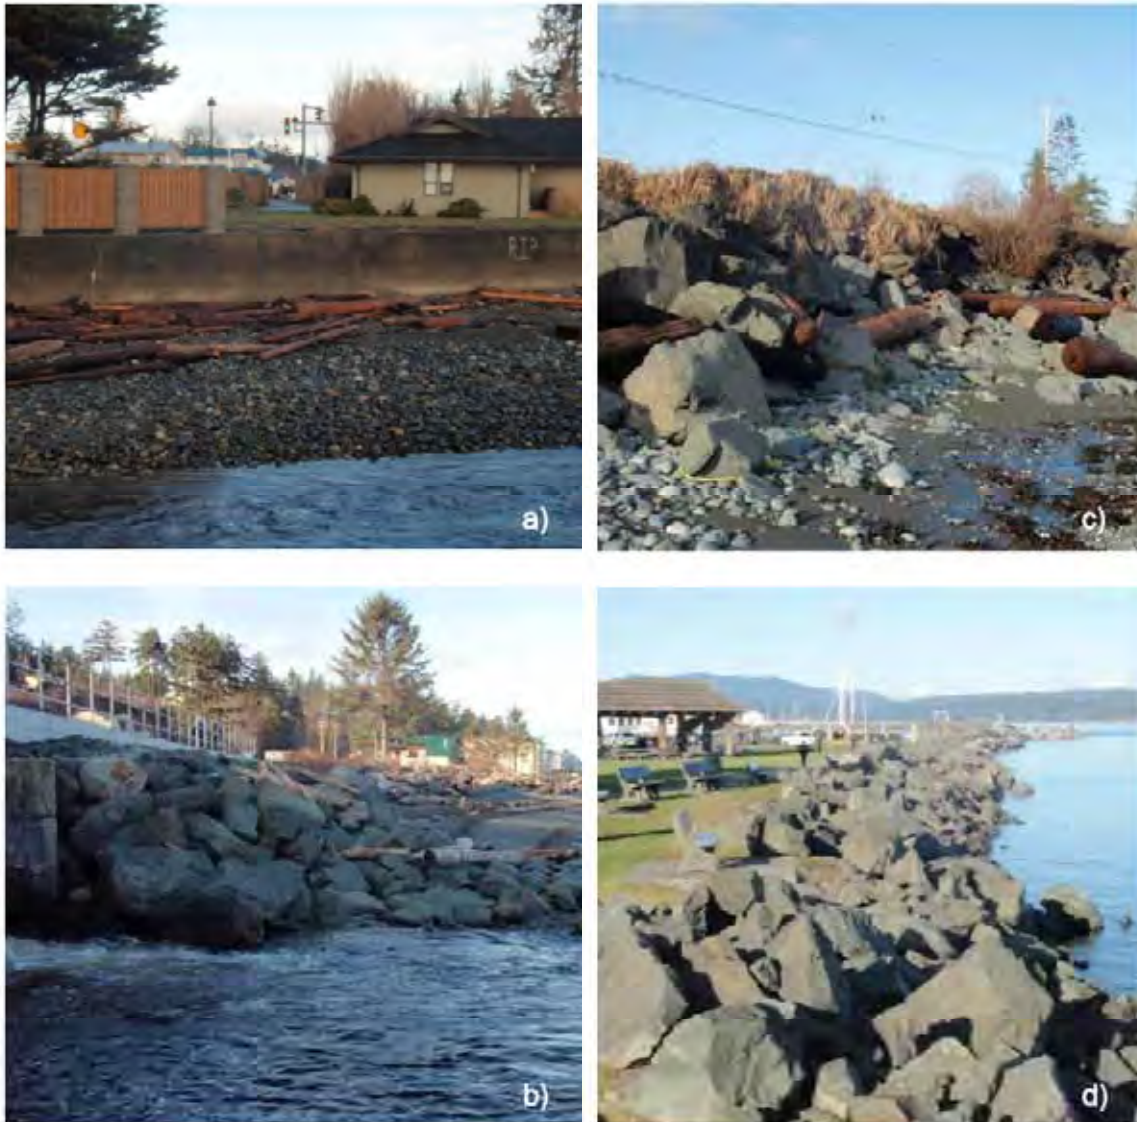
Figure 9. Typical bank armoring along the CoCR foreshore; a) vertical concrete wall at Willow Creek, b) loc-bloc and rock wall protection along new Island Highway South at Simms Creek, c) steep failing riprap near the end of Dahl Road, and d) rock riprap lined shoreline at Frank James Park (all photos 17 January 2011).

- Figure 9. Typical bank armouring along the CoCR foreshore: a) vertical concrete wall at Willow Creek, b) loc-bloc and rock wall protection along new Island Highway South at Simms Creek, c) steep failing riprap near the end of Dahl Road, and d) rock riprap lined shoreline at Frank James Park (all photos 17 January 2011).

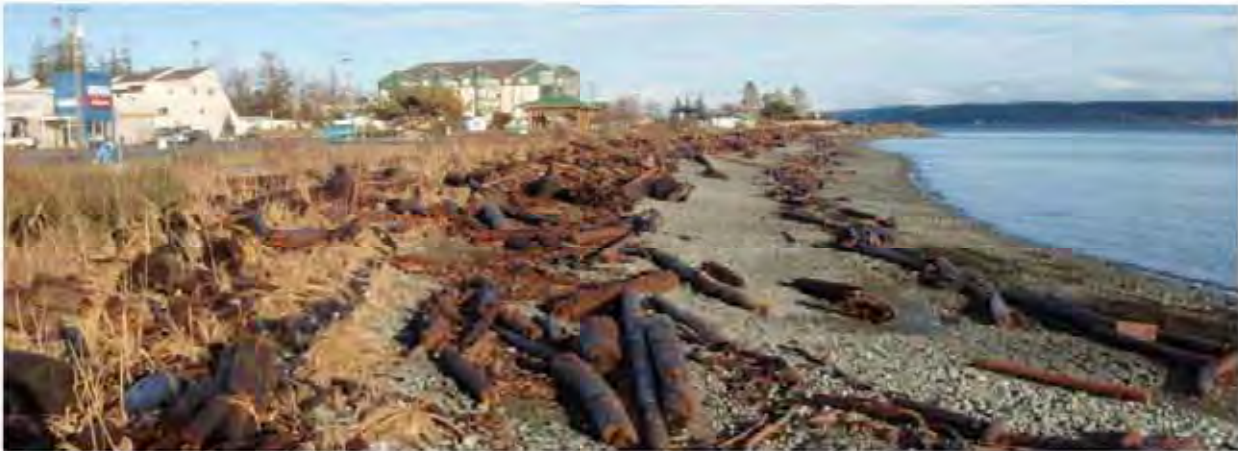
Photo 1. Semi-natural beach south of Willow Point. Note the relatively gentle beach profile and retention of logs (photo 17 January 2010).

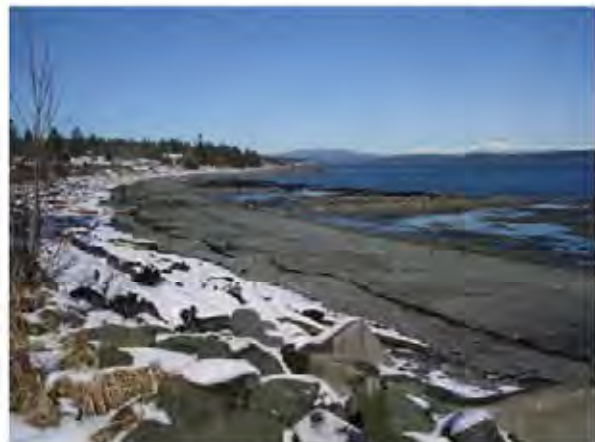
Photo 9. Substrates and intact supralittoral berm at Frank James Park.

Substrates in the high intertidal zone at Frank James Park consist of continuous lengths of sand and pebble substrates greater than 5 m in width that appear to be appropriate for forage fish spawning (**Photo 9: Map 3 – Sheet 1**). There was also an intact supralittoral zone with integrated LWD that improves the potential for use of the area by forage fish. Moving north, appropriate forage fish spawning substrates and intact supralittoral zones were still observed, however suitable substrates became slightly more patchy, with some sections of coarse or thin substrates interspersed throughout the reach until a point 25 m north of Big Rock Park (north) at which point the substrates transition to cobble dominated areas with too few fines to support successful spawning habitat. The Simms Creek estuary appears to be a significant source of finer sediments for the beach system; these substrates are seeding potential spawning habitat in the local area. It is likely the constructed breakwater at the Simms Creek estuary is functioning to cause accretion of substrates at this location. Between a point 25 m north of Big Rock Park and

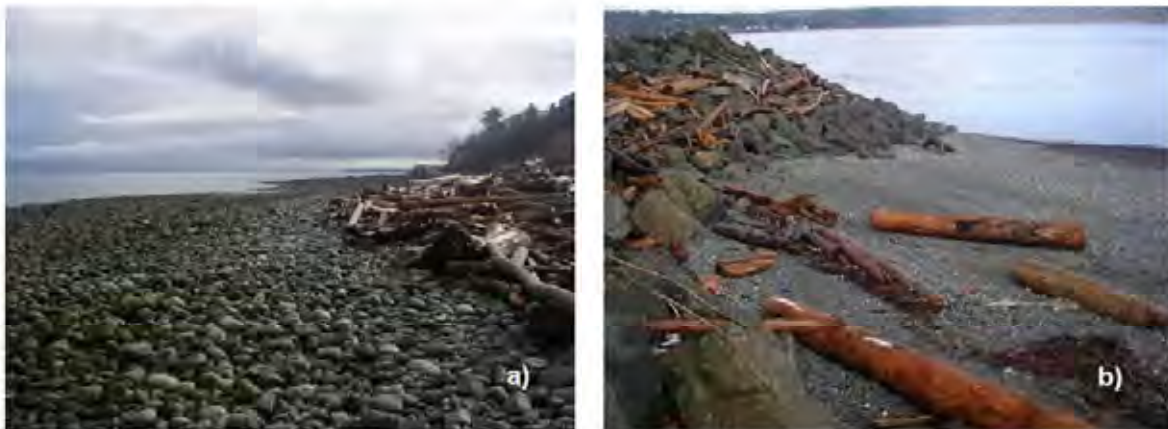
Photo 12. Typical substrate conditions within Reach 4 – Southern Bluffs: a) substrates in the high intertidal zone at Sequoia Park, and b) sediment accretion at the south side of the Marine Heritage Center Park breakwater.

With the exception of a small beach immediately south of the breakwater at the Maritime Heritage Center, observations of substrates in the high intertidal zone along this reach indicate that there is a total lack of fine substrates that precludes forage fish spawning activity. Field results at Sequoia Park indicate that there is a functional/intact supralittoral zone with integrated LWD, however substrates in this reach are “starved” of fines and are dominated almost exclusively by cobbles (**Photo 12a**). This may be a result of the large breakwater at Hidden Harbour.

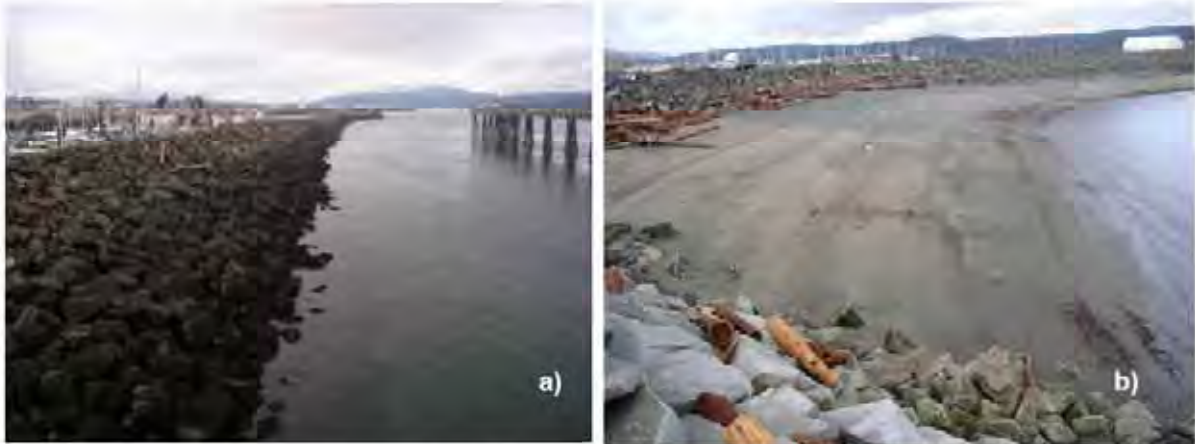
Photo 14. Typical foreshore and substrate conditions within Reach 5 – Industrial: a) breakwater located at the Government Wharf Marina (Discovery Pier in right side of photo), and b) small sand substrate beach located 250 north of the Ferry Terminal.

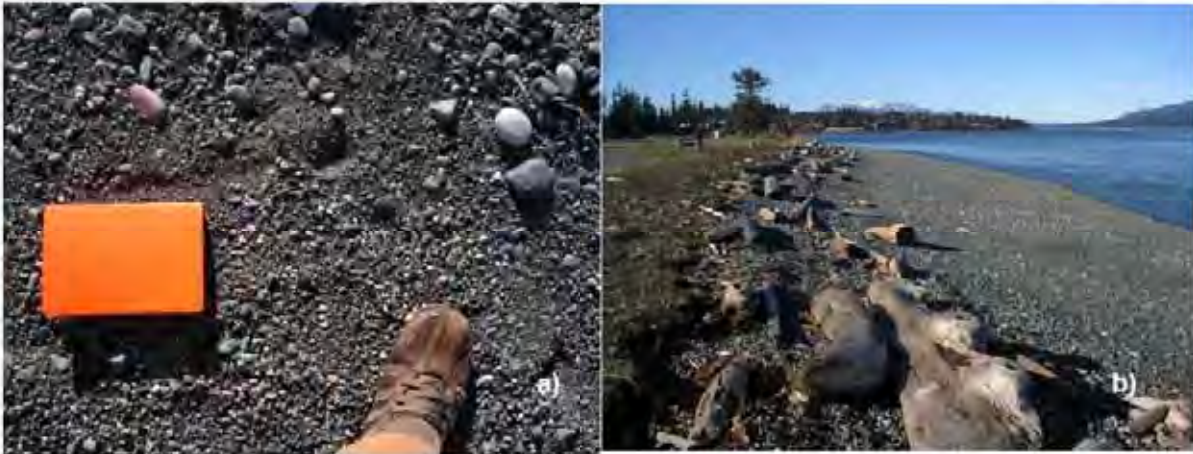
Photo 16. Typical substrate and foreshore within Reach 6 – Estuary: a) substrates lacking in finer sand component at Dick Murphy Park, and b) shoreline profile at Dick Murphy Park. Note sparse backshore vegetation.

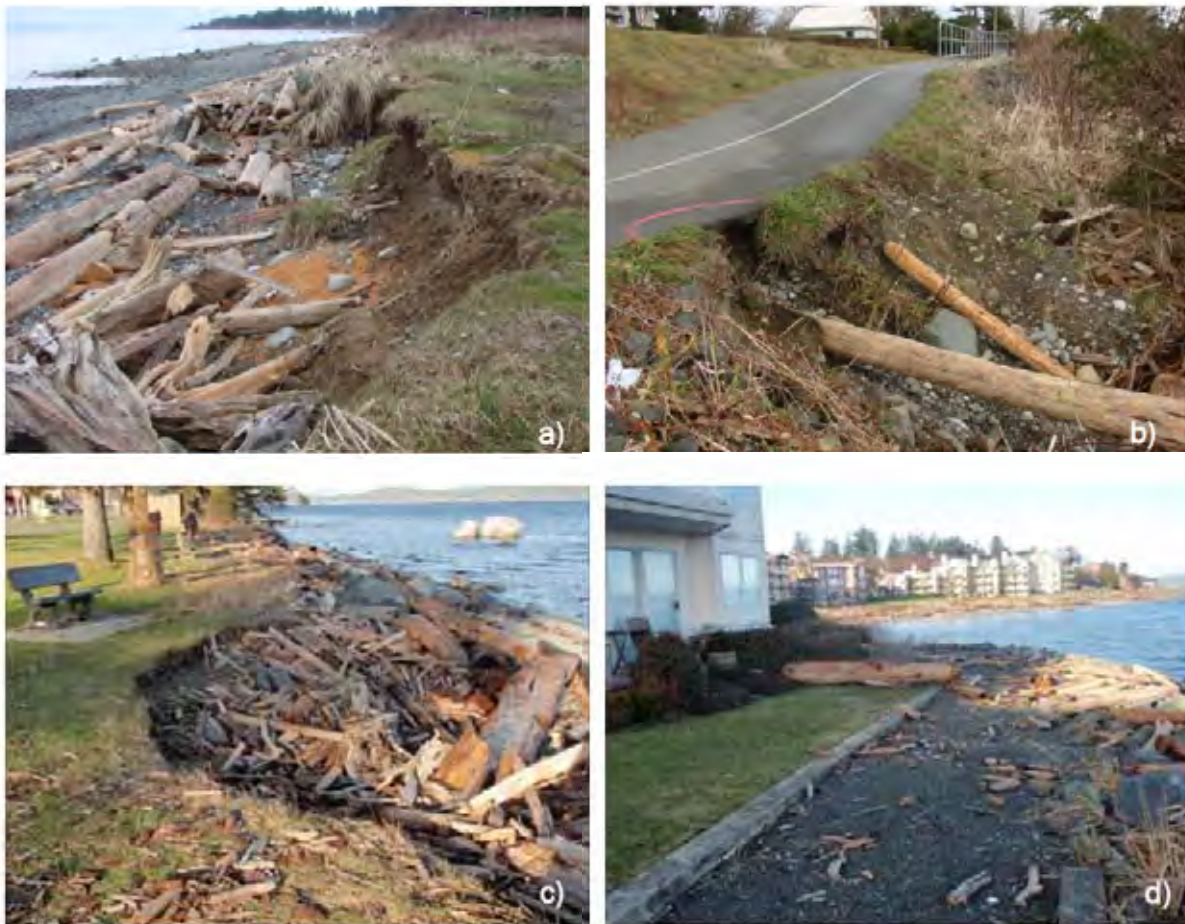
Figure 12. Photos showing conditions at the high priority sites (see Table 16): a) south of Maryland Road, b) south of Twillingate Road, c) Rotary Beach Park, and d) Seaside Estates (photos 17 January, 2011).

- Figure 12. Photos showing conditions at the high priority sites (see Table 16): a) south of Maryland Road, b) south of Twillingate Road, c) Rotary Beach Park, and d) Seaside Estates (photos 17 January, 2011).

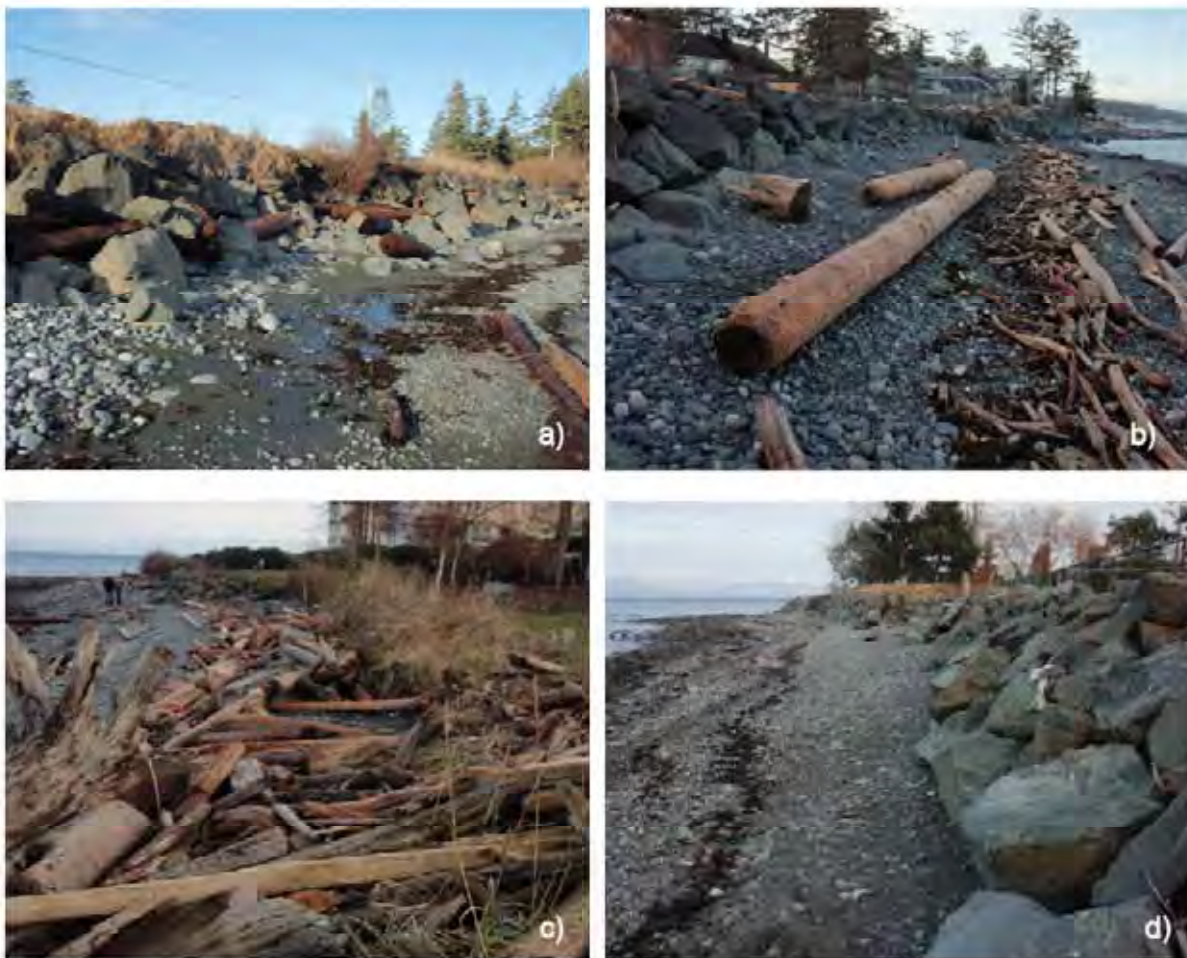
Figure 13. Photos showing conditions at the lower priority sites (see Table 17): a) along shore near Twillingate Road, b) Larwood Park, c) Adams Park, and d) Frank James Park (photos taken 17 January, 2011).

- Figure 13. Photos showing conditions at the lower priority sites (see Table 17): a) along shore near Twillingate Road, b) Larwood Park, c) Adams Park, and d) Frank James Park (photos taken 17 January, 2011).

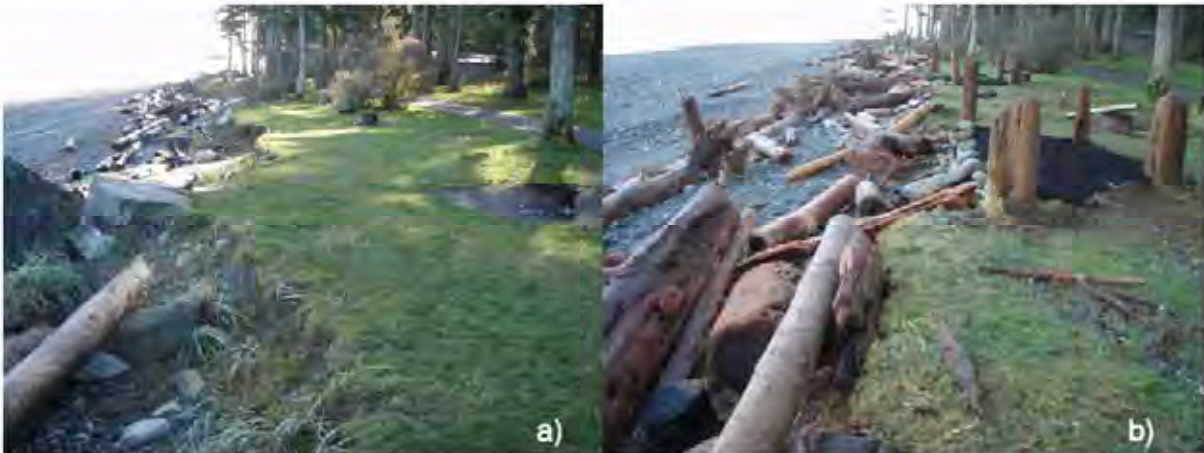
Figure 14. Views looking south along the shoreline at Kitty Coleman Provincial Park, a) prior to restoration work, and b) after the year-one project completion.

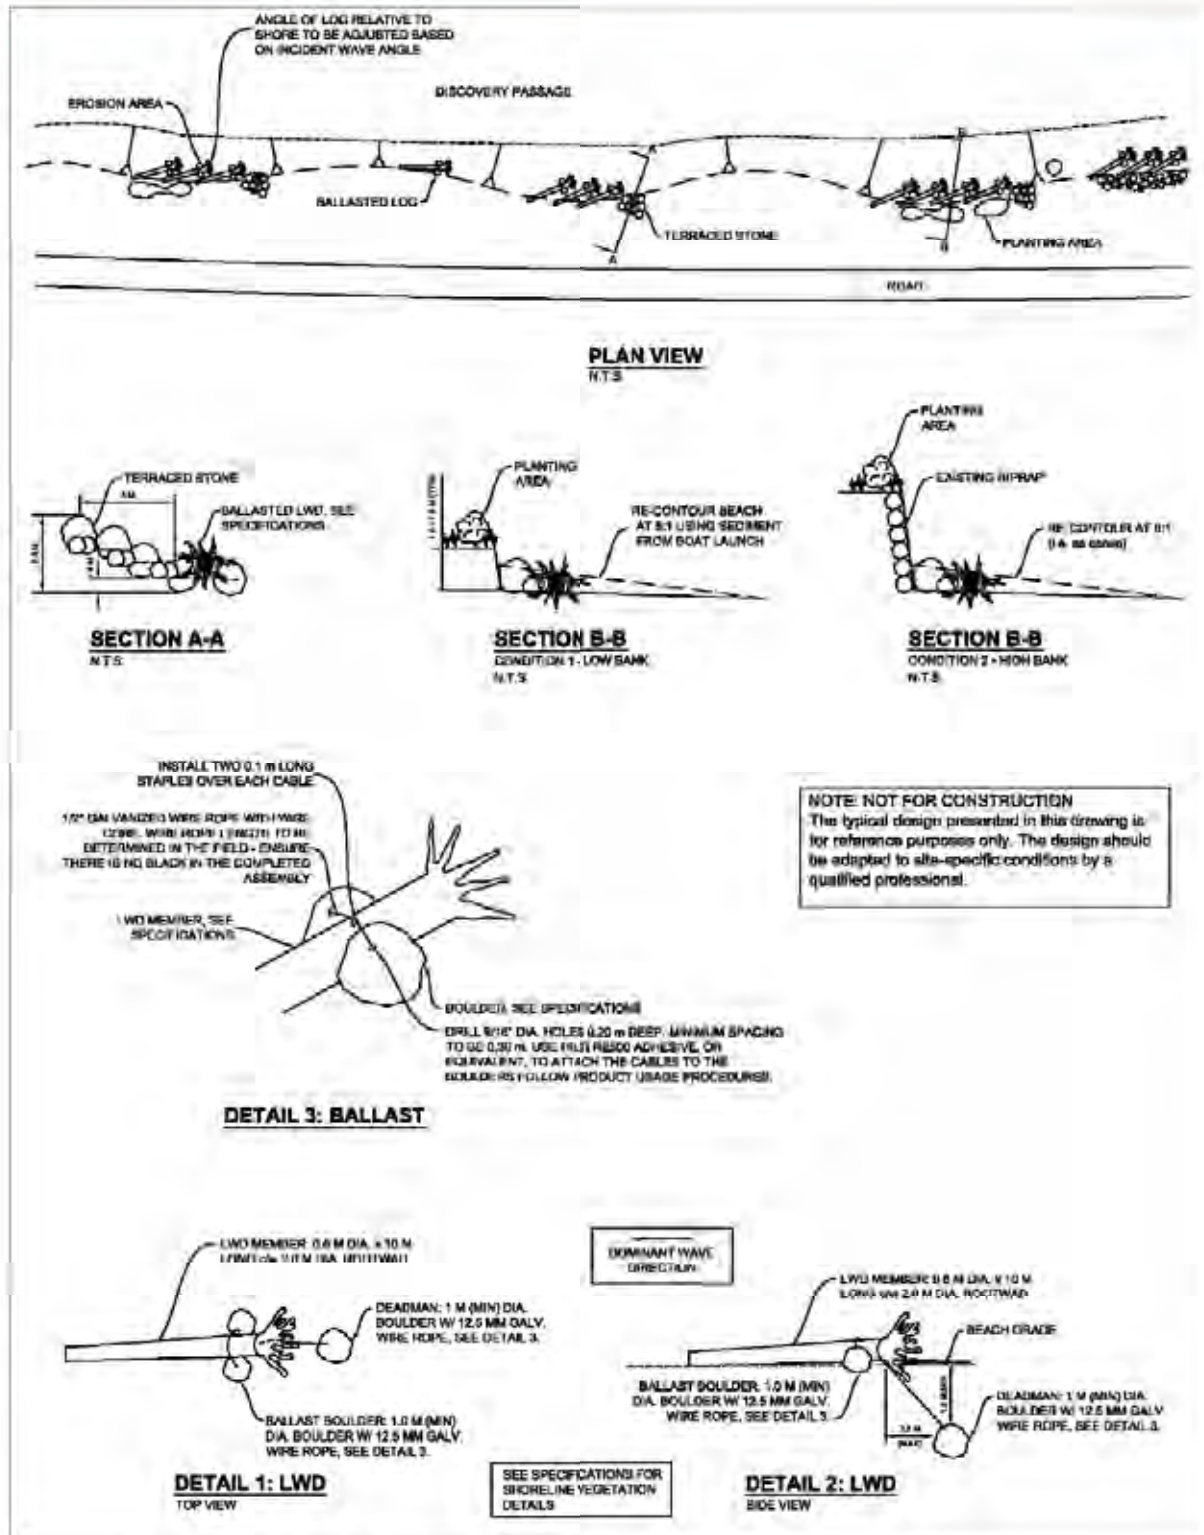
Figure 15. Typical soft shoreline protection design.

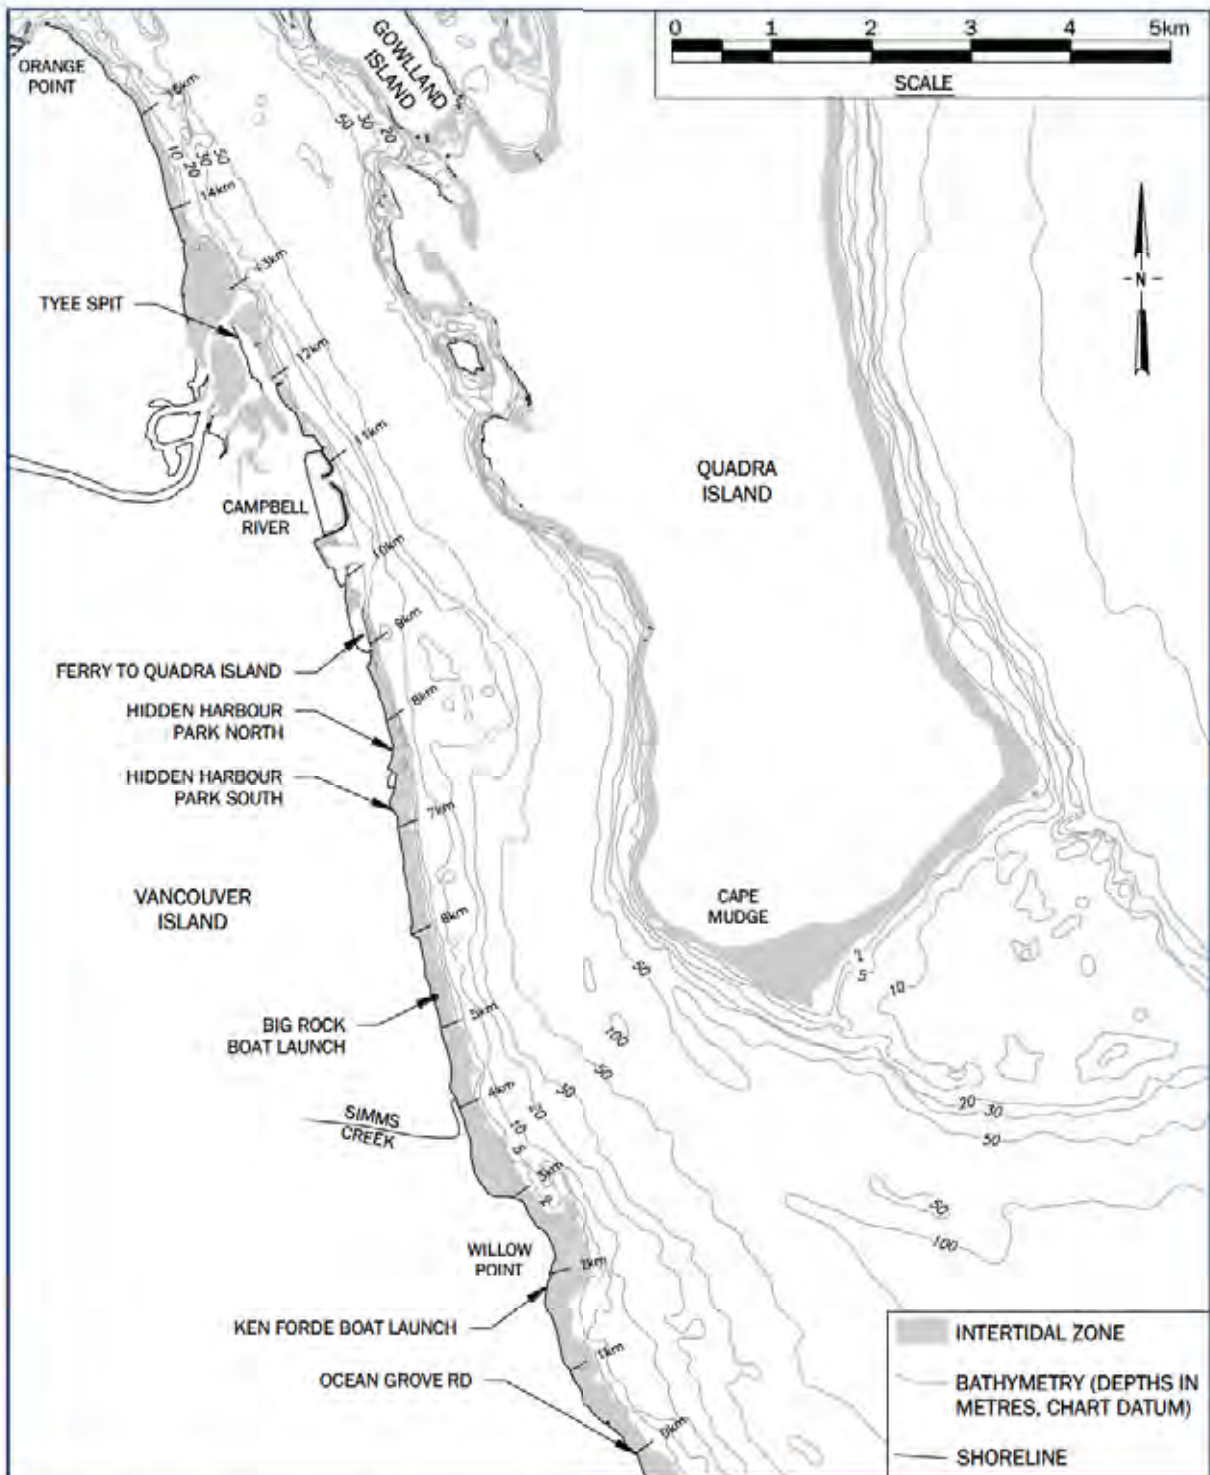
Figure A-3. Bathymetry near Campbell River.

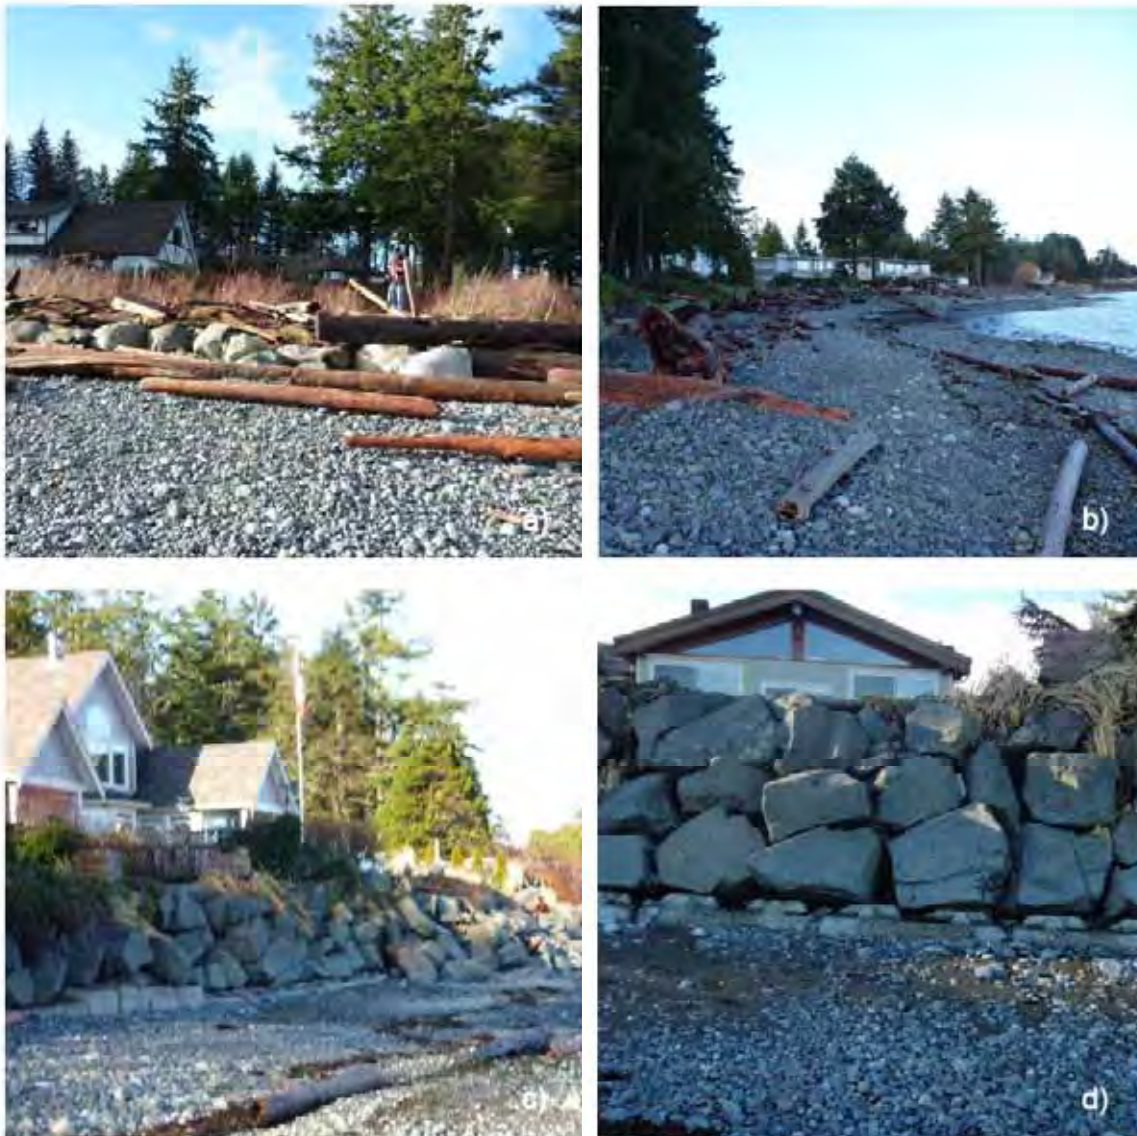
Figure A-4. Various photos showing shoreline conditions north of Ocean Grove Road (photos taken 17 January 2011).

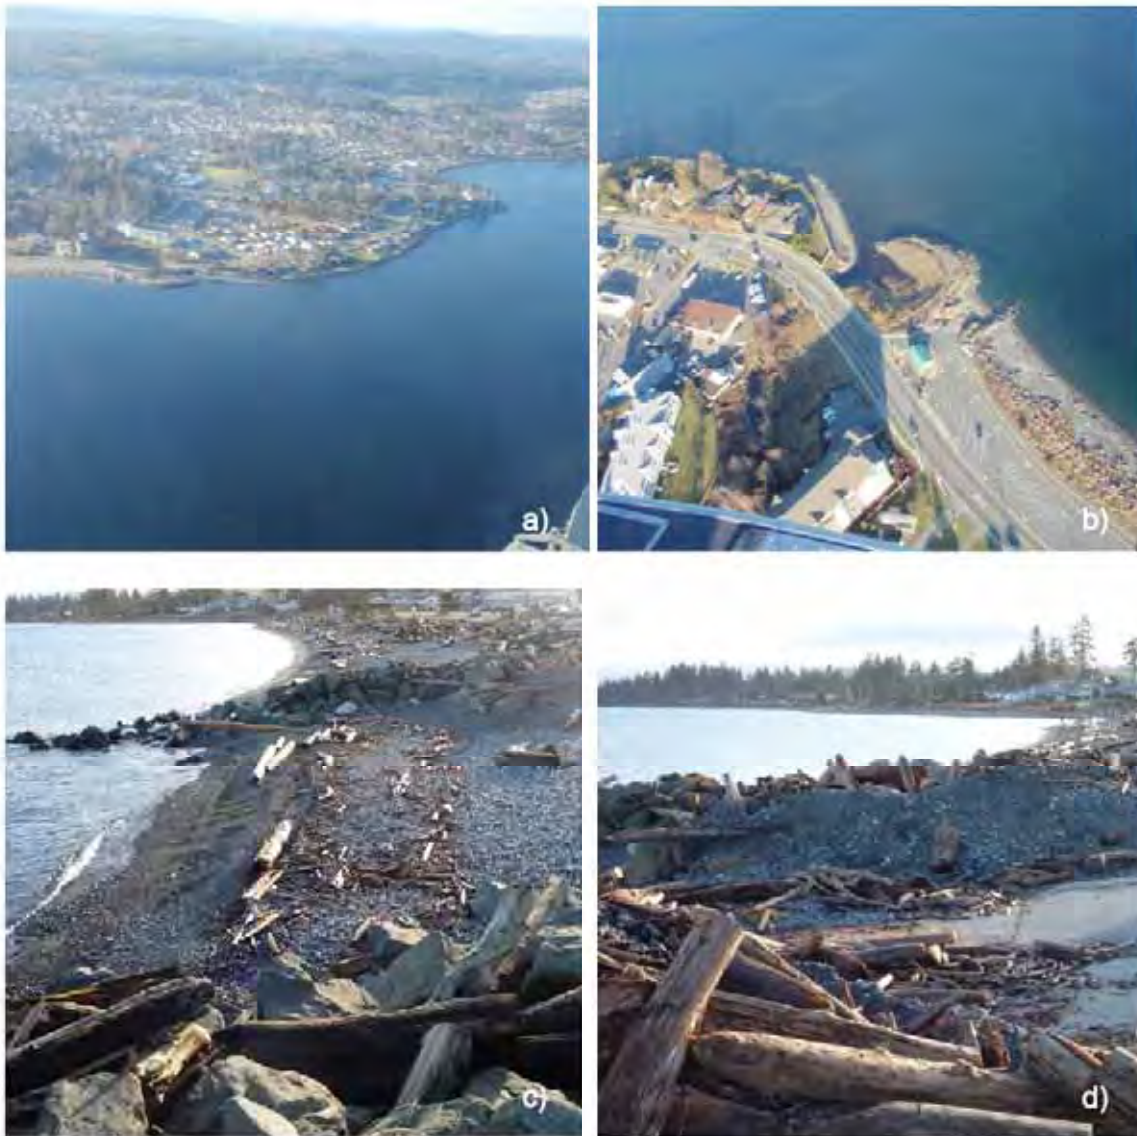
Figure A-5. Various photos showing shoreline conditions in the Willow Point area (a and b) and Ken Forde Boat Launch (c and d) (photos taken 17 January 2011).

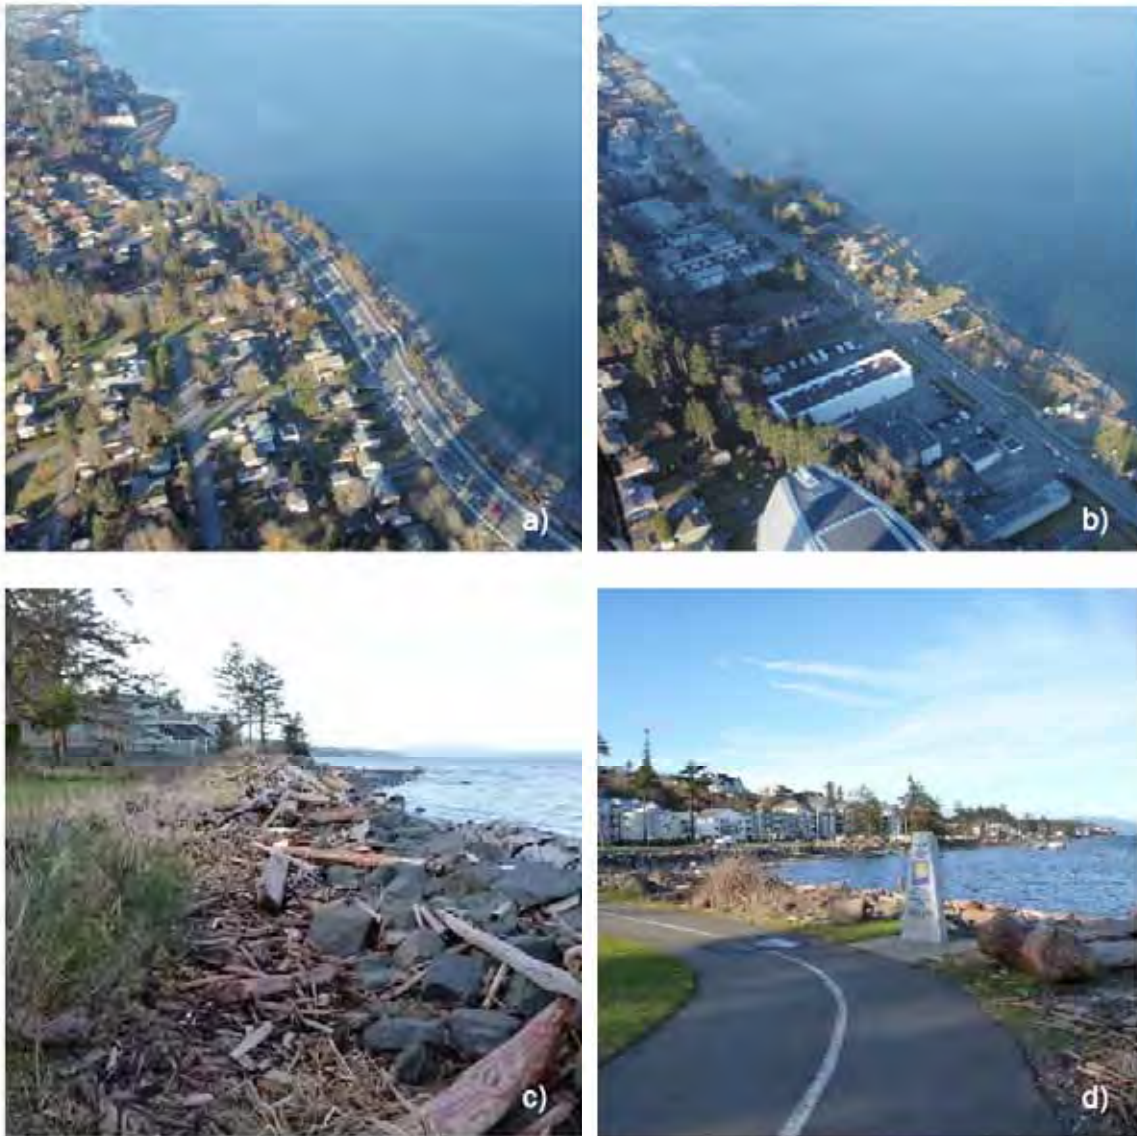
Figure A-6. Various photos showing shoreline conditions from McCallum Park to Rotary Park (photos taken 17 January 2011).
