City of Campbell River
Marine Foreshore Habitat Assessment and
Restoration Plan

FINAL REPORT

Northwest Hydraulic Consultants Ltd.
Current Environmental
Murdoch de Greeff Inc.

December, 2011

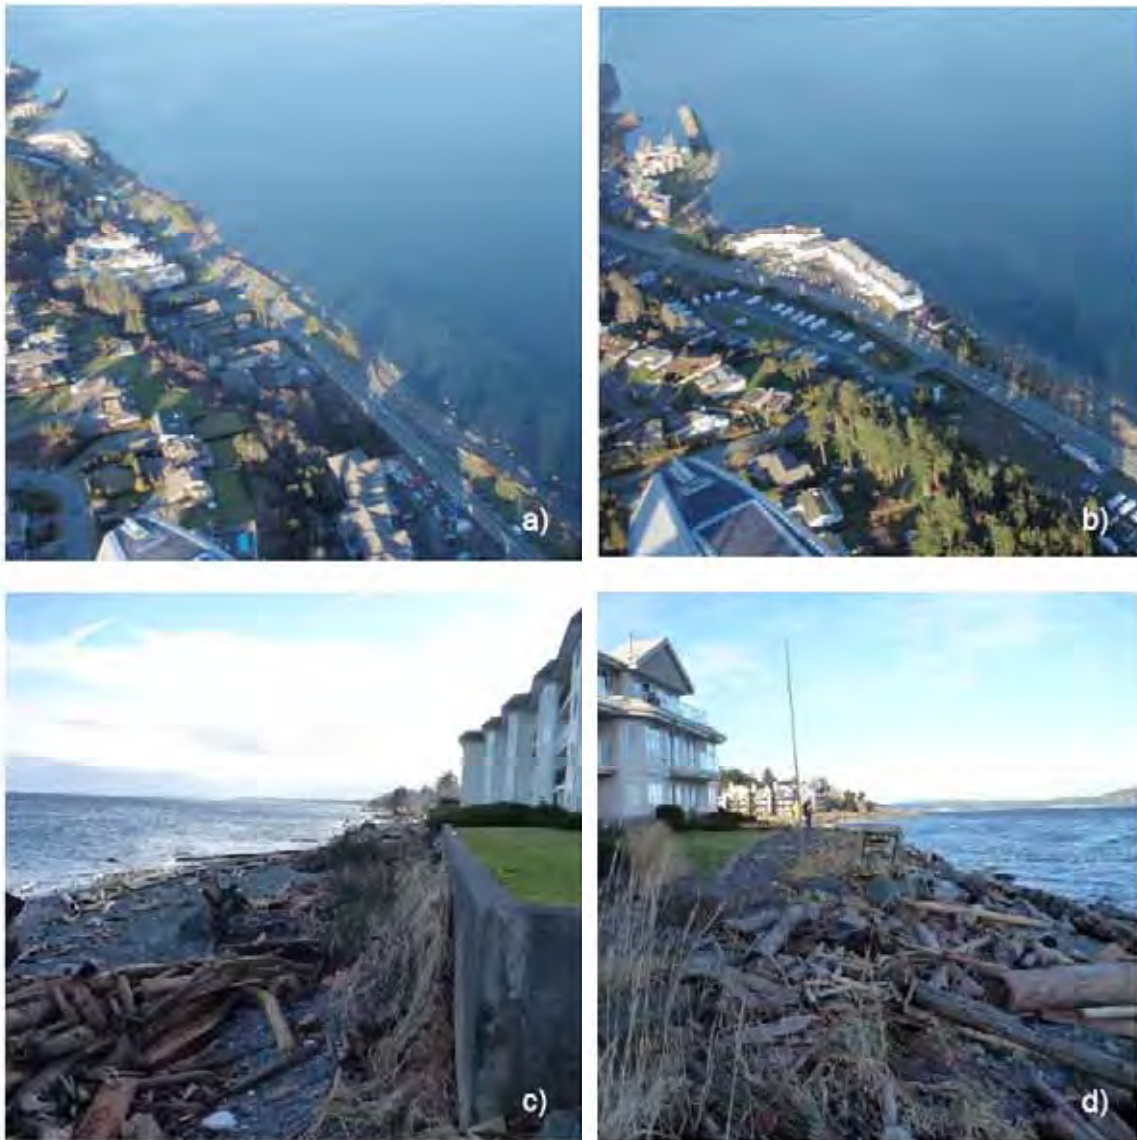
Figure A-7. Various photos showing shoreline conditions from Rotary Park to Hidden Harbour Park (photos taken 17 January 2011).

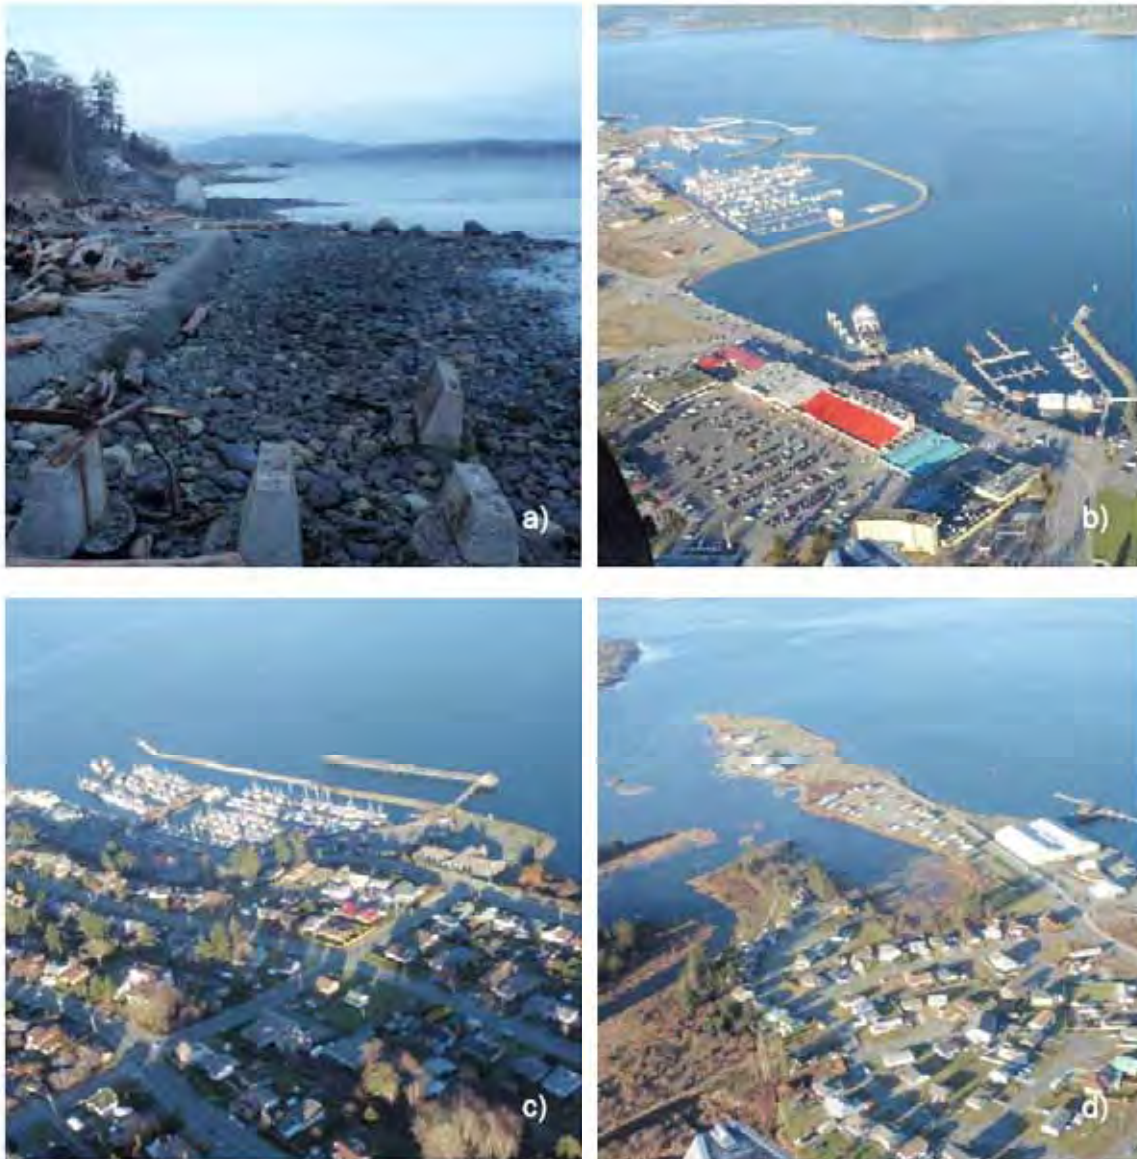
Figure A-8. Various photos showing shoreline conditions from Hidden Harbour Park to Tye Spit (photos taken 17 January 2011).

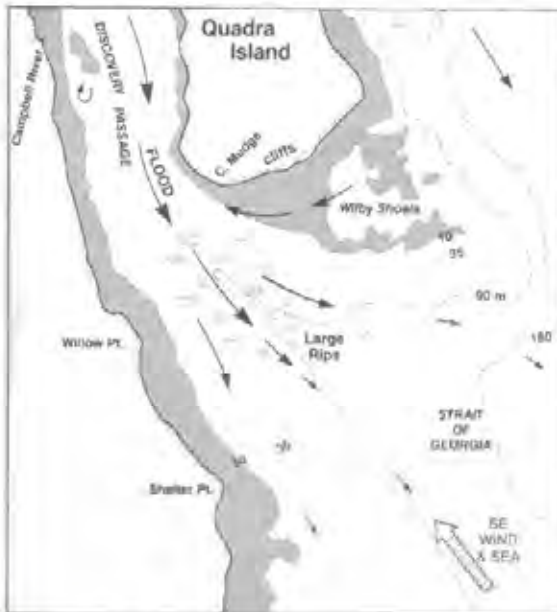
Figure A-9. Rip currents at southern end of Discovery Passage (from Thompson, 1981).

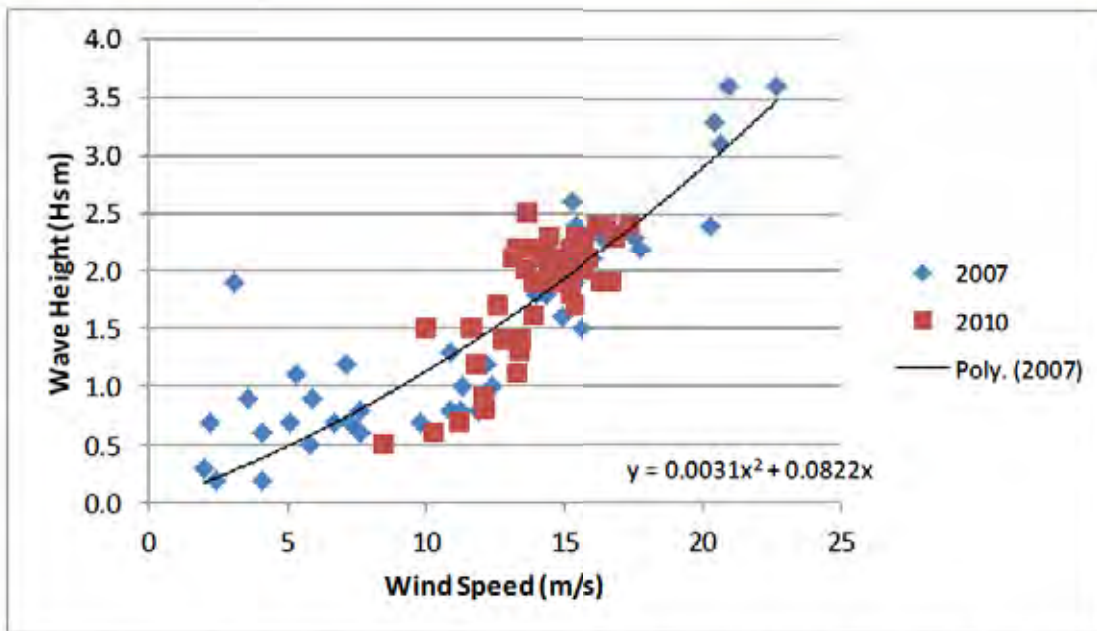
Figure A-11. Observed wave height at Sentry Shoal versus wind speed (SE Storms).

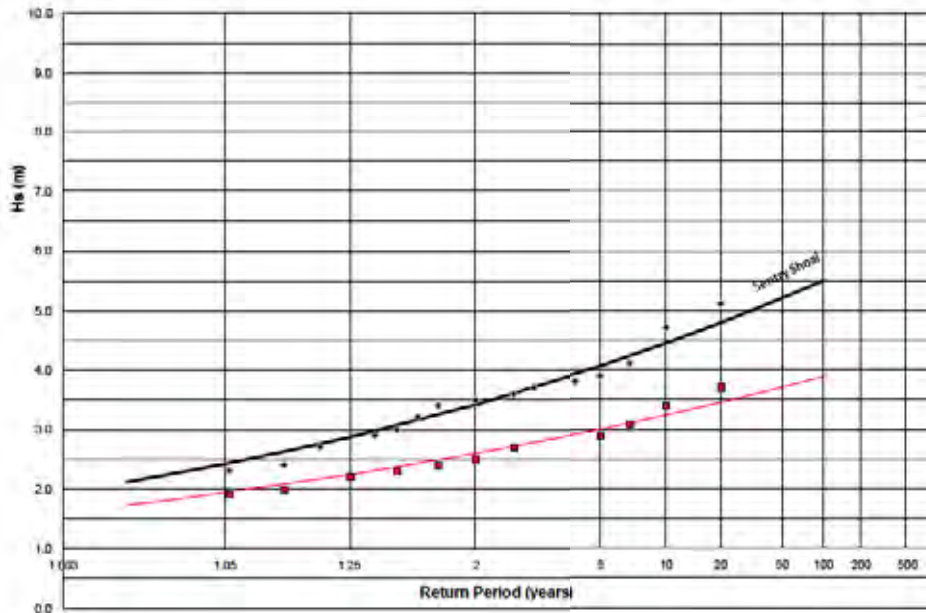
Figure A-12. Frequency analysis of observed deep water wave heights at wave buoys in the Strait of Georgia.

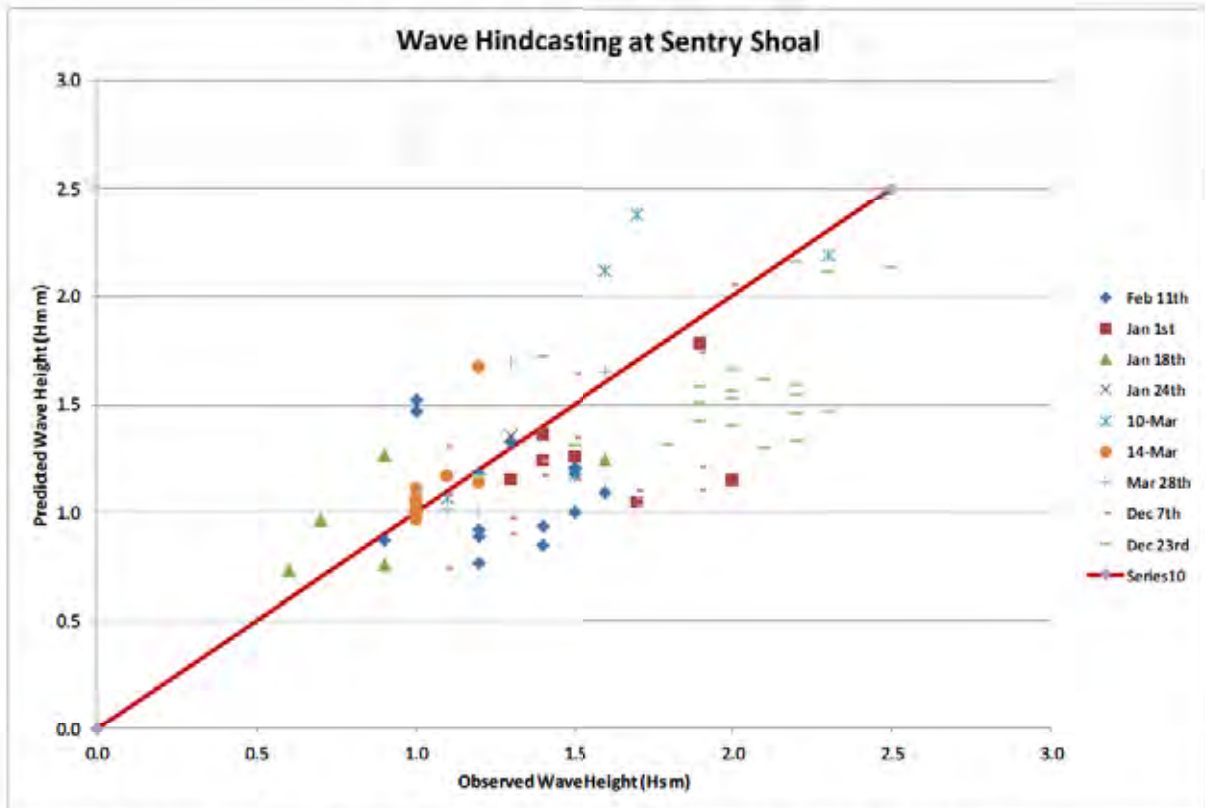
Figure A-13. Predicted versus observed wave heights at Sentry Shoal.

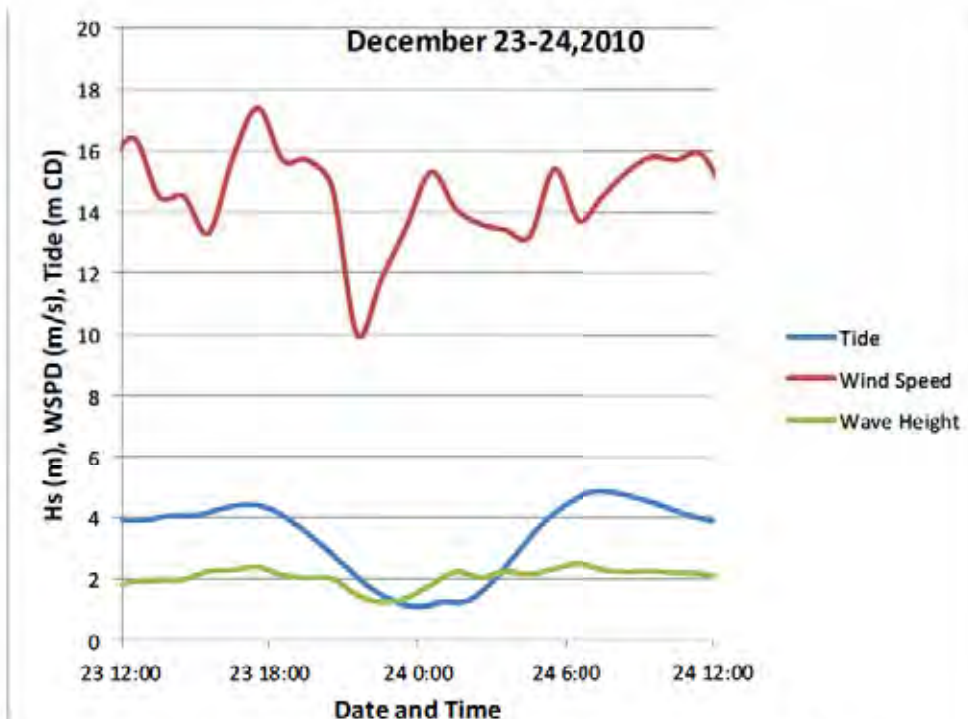
Figure A-17. December 23-24 2010 storm near Campbell River.

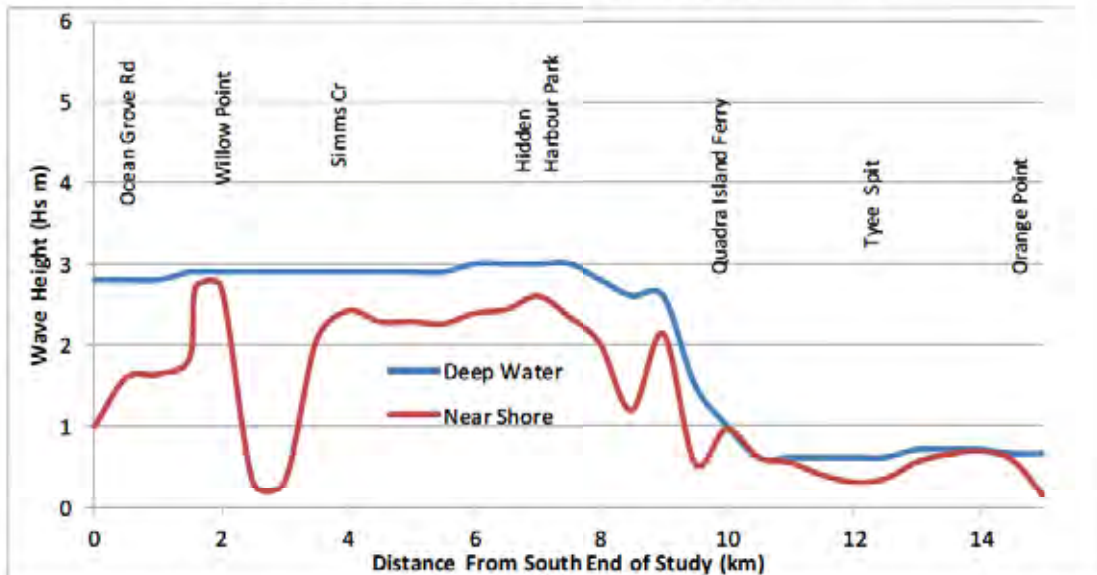
Figure A-18. Variation in wave height along the shoreline at Campbell River – December 23, 2010 storm event.

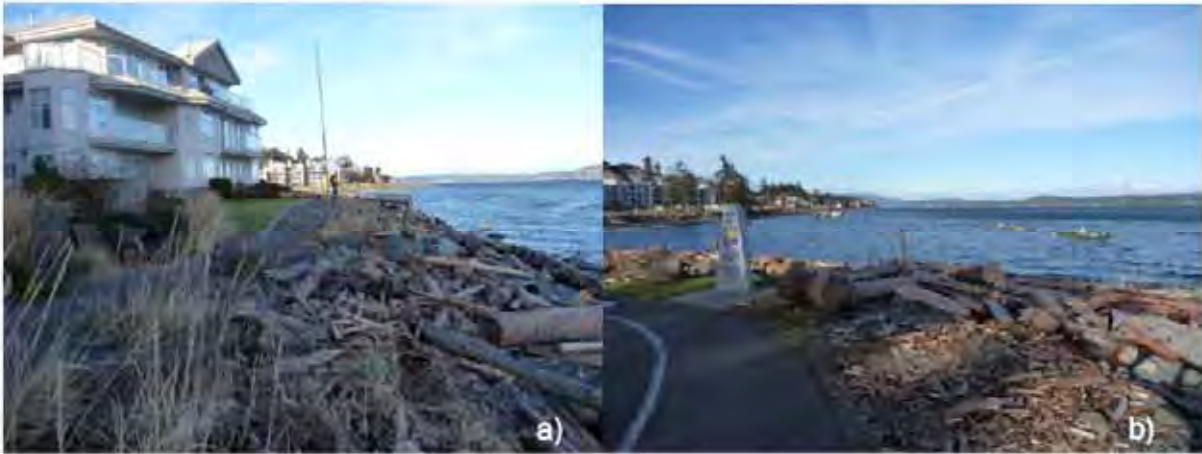
Figure A-19. Photos showing debris from recent wave runup (photos taken 17 January 2011).

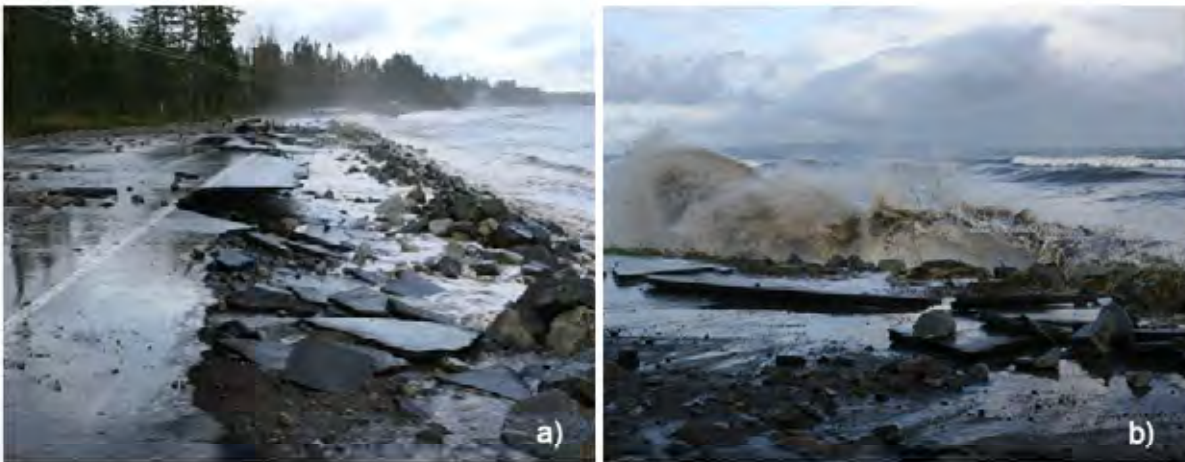
Figure A-20. Photos showing damage to Highway 19A during 2007 storm.

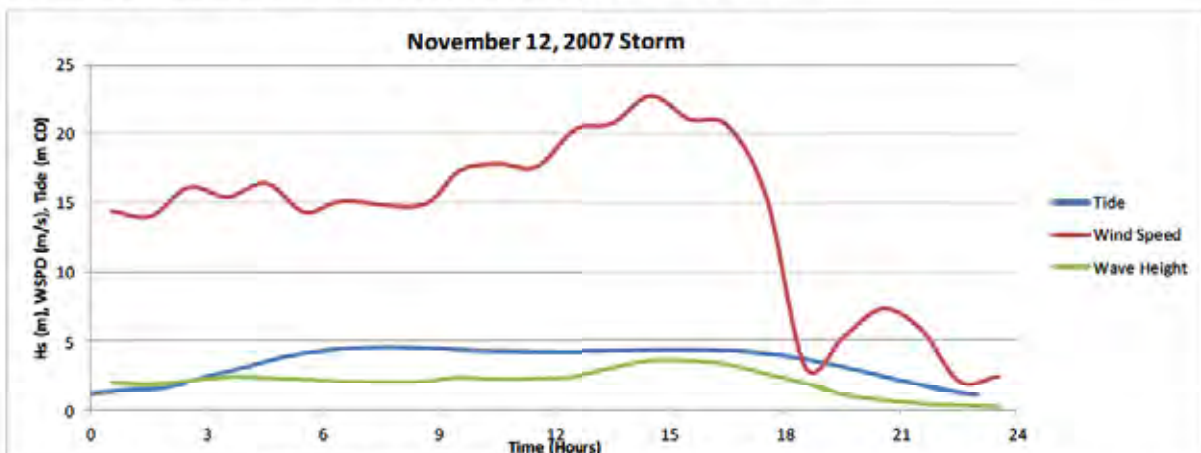
Figure A-21. Wave heights, wind speed and tide levels during November 2007 storm near Campbell River.

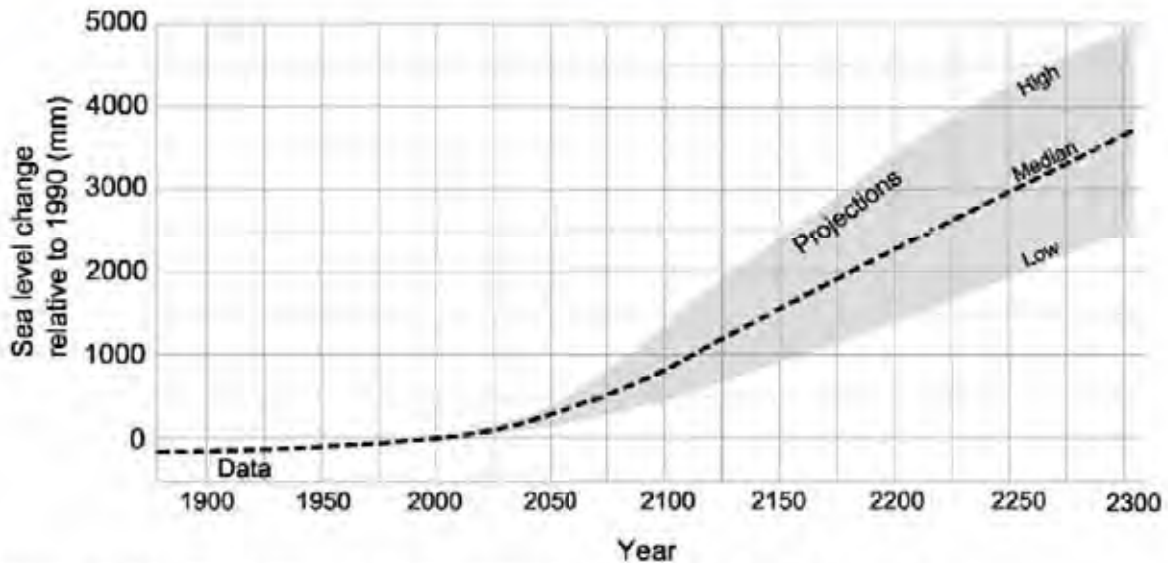
Figure A-24. Projection of sea level rise in BC (from BC MOE, 2010).

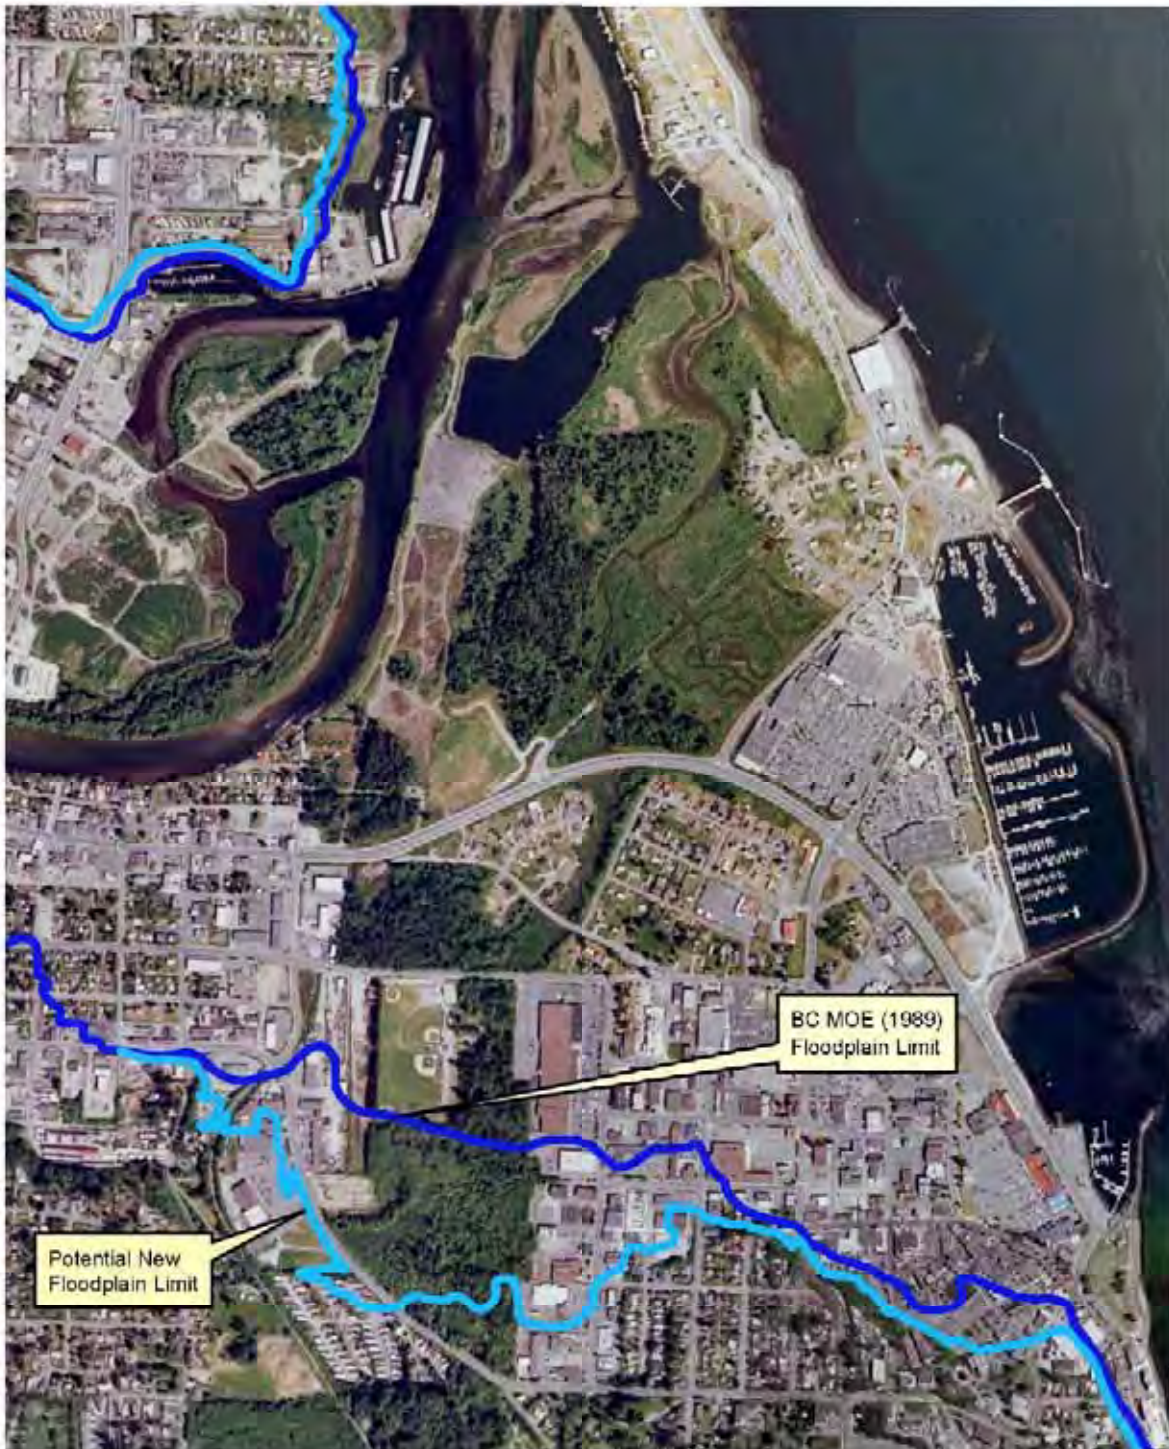
Figure A-25. Floodplain extents based on existing mapping (Campbell and Quinsam Rivers, BC MOE, 1989) and on future sea level rise scenario.

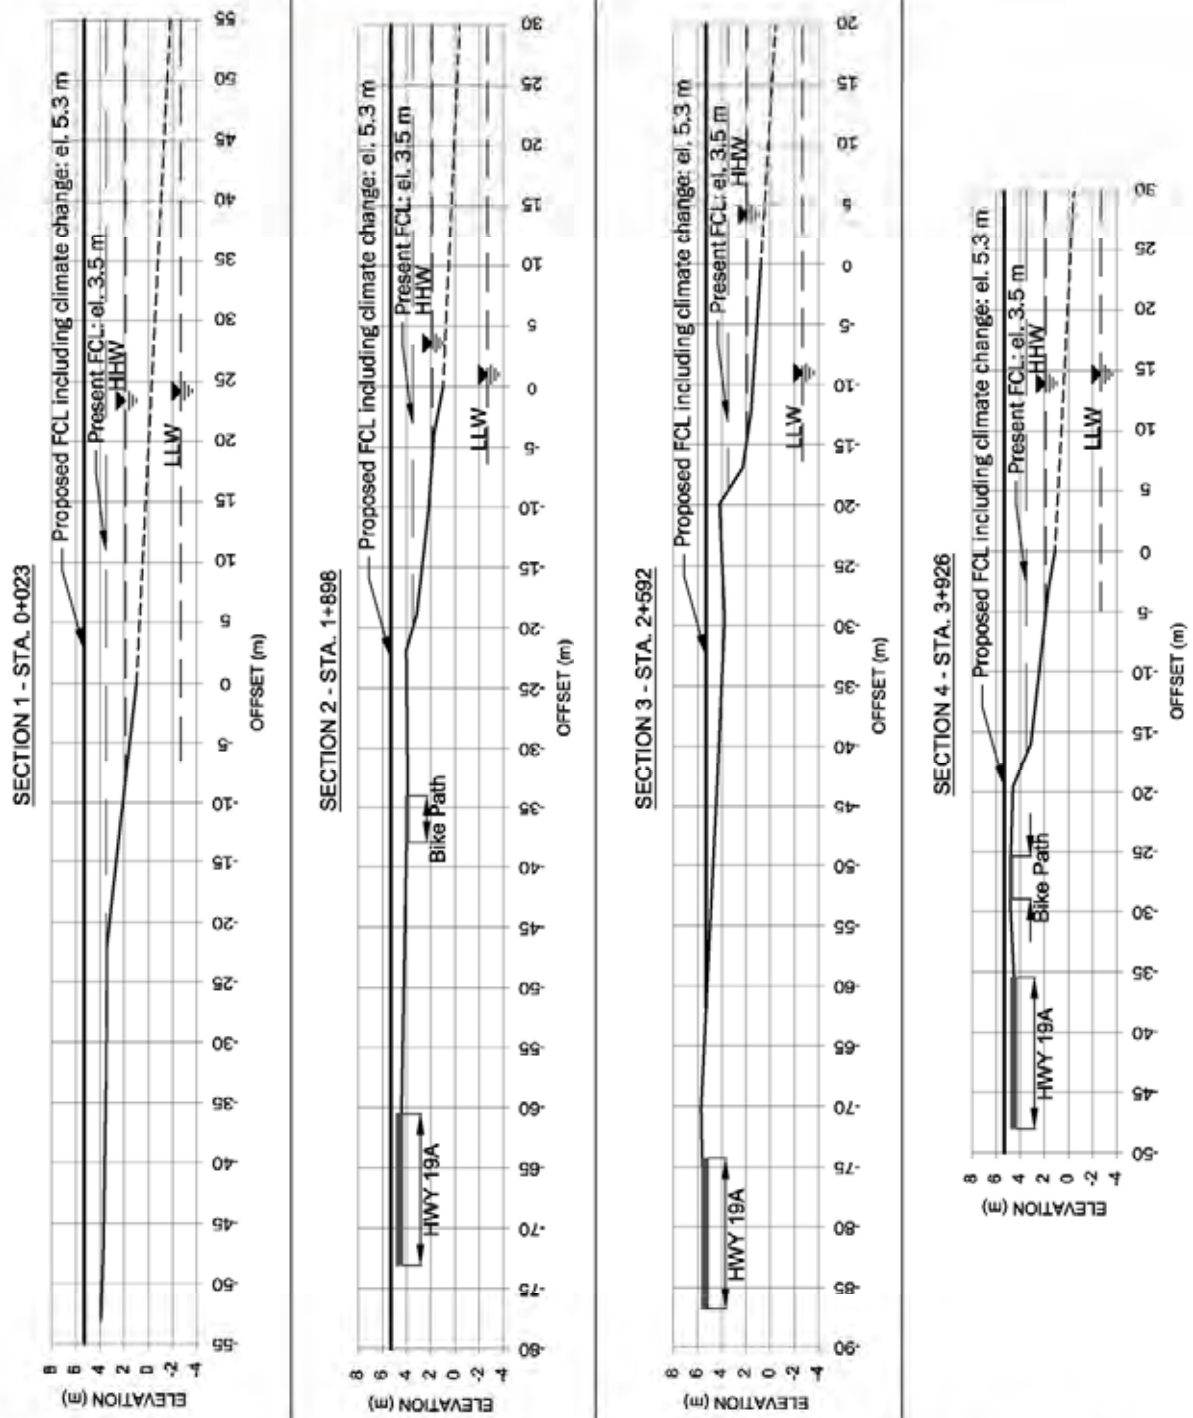
Figure A-26. Shoreline profiles – Sections 1 to 4, showing BC MOE’s present and proposed Coastal FCL.

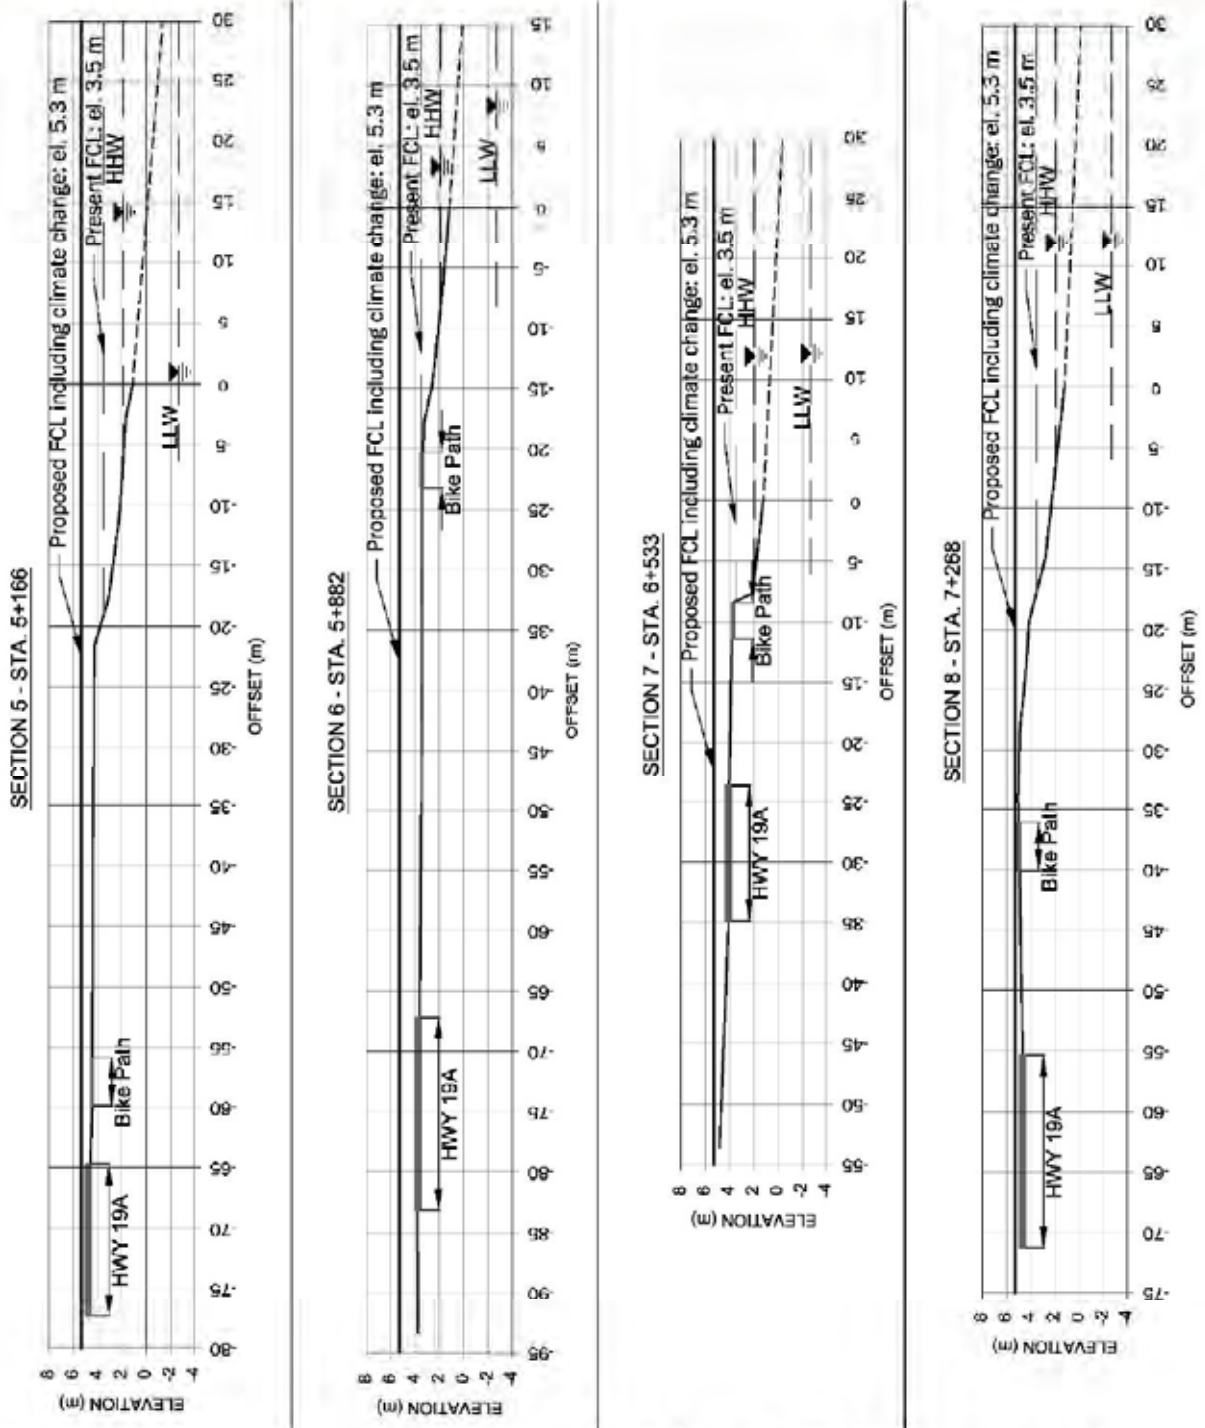
Figure A-27. Shoreline profiles – Sections 5 to 8 showing BC MOE’s present and proposed Coastal FCL.

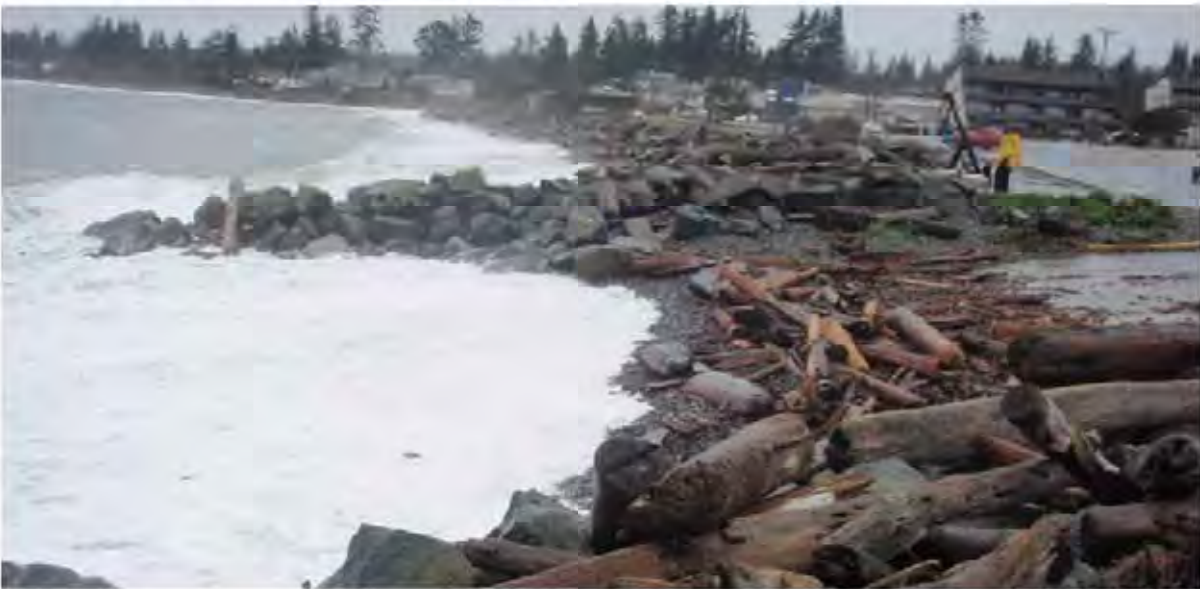
Photo B-2. Sediment and debris depositing on Ken Forde boat ramp during the 31 November 2010 storm.

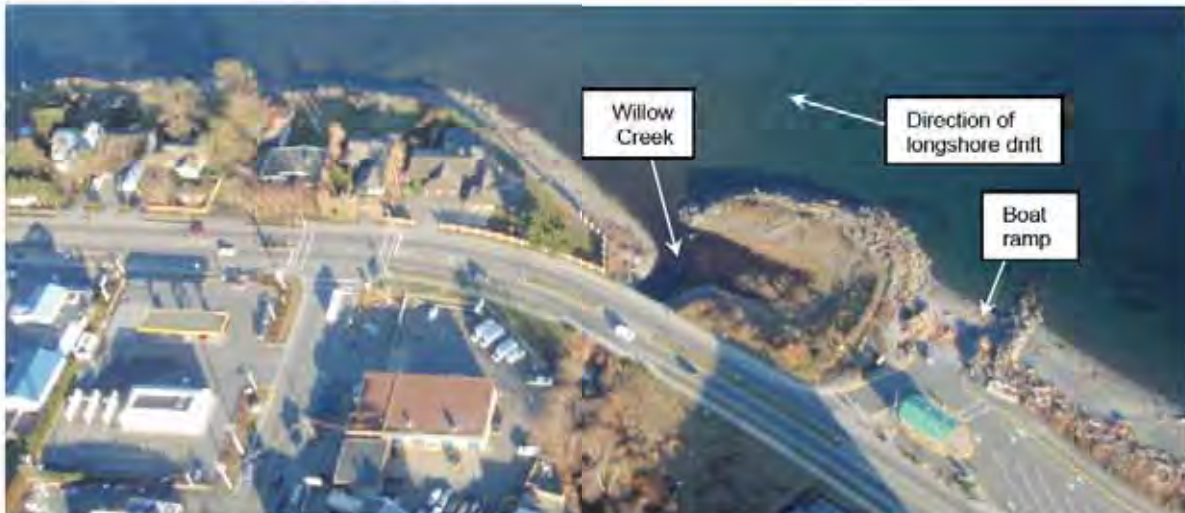
Photo B-4. Oblique aerial view of Ken Forde Boat Ramp (photo taken 18 January 2011).
